## **Central Java Earthquake Assessment of Rehabilitation and Reconstruction Needs**

### **Report of Survey on the Prevention of Secondary Disasters (Sediment-related Disaster Planning)**

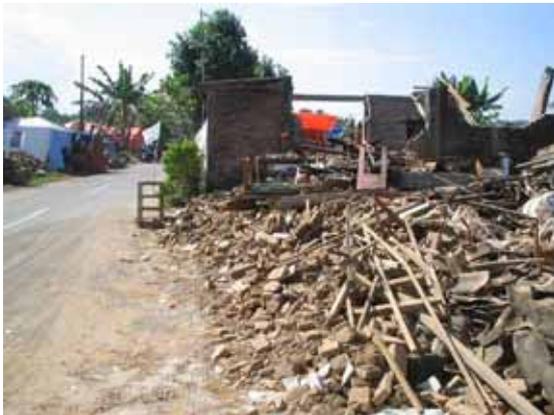
This earthquake caused extensive damage including 5,738 deaths, 48,873 completely destroyed and 118,714 damaged houses. (The death toll of the victims was released by the National Disaster Management and Refugee Coordination Agency on June 8 and the building damage by the Ministry of Social Welfare on May 31.) Damage to houses was studied on site, which showed that most of the ordinary houses had a structure with walls of bricks laid with poorly mixed concrete topped with a roof of logs of a few centimeters square covered with tiles and were structurally highly vulnerable to earthquakes (Photo 4.2). The tiles broken to pieces due to the collapse of houses were often found, suggesting extremely low strength.

**Photo 4.1: Damage to houses caused by the earthquake (Bantul District)**

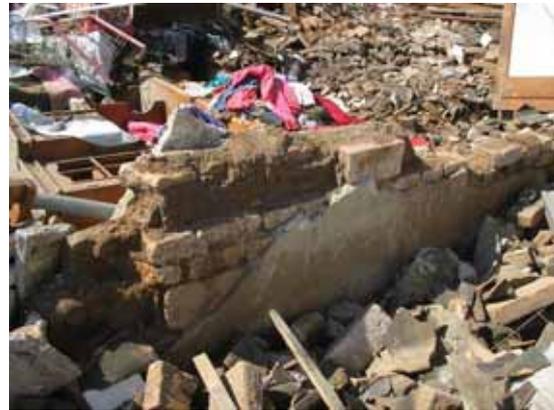
**Photo 4.2: Wall structure: bricks laid with muddy mortar**

There is almost no doubt that the collapse of these houses that were structurally very vulnerable to earthquake motions added to the damage. Damage to other buildings such as hospitals and schools was also serious. On the contrary, damage to civil engineering structures such as roads and bridges was minor and no utility poles were found fallen even in areas that suffered massive collapse of houses. The development of and strict adherence to anti-seismic standards of building structures is necessary.

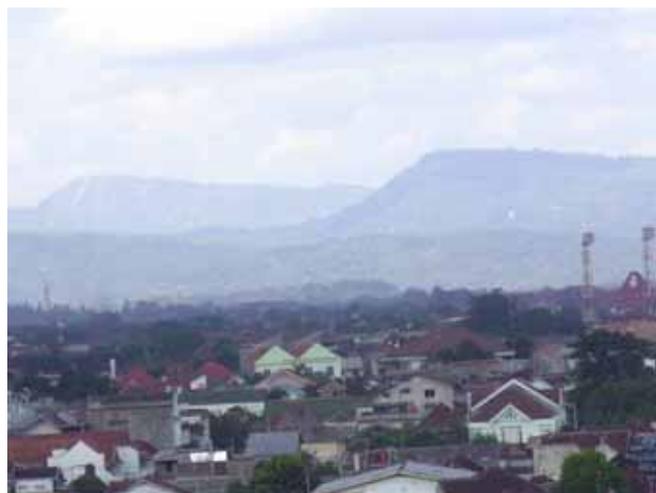
The topography can be described as hilly mountains of about 500 m above sea level. While the slopes facing northwest or north make cliffs (on the Bantul and Sleman side) that fall into a plain stretching from Yogyakarta, the slopes facing southeast to south that are on the other side (on the Gunungkidul side) are gentle inclines, which make a cuesta topography (Figure 5.2, Photo 5.1).

**Photo 5.1: Cliffs in the mountain terrain studied**

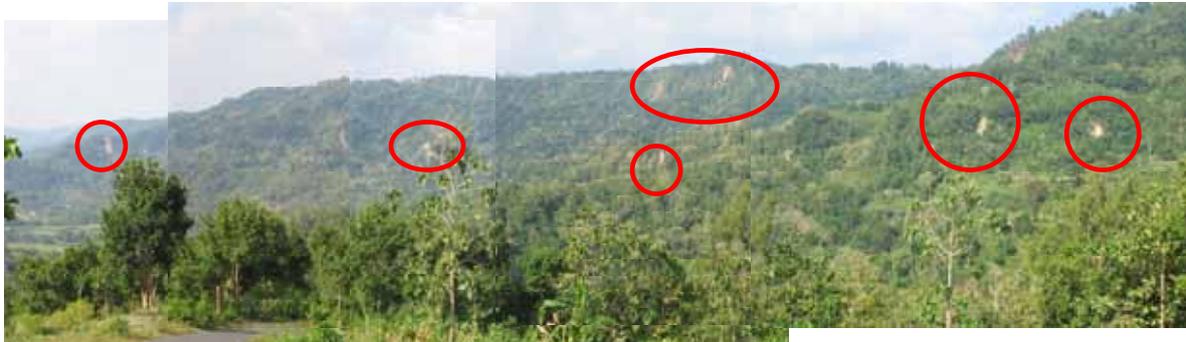
As a result of the study, failures have been observed all over the hillside near the epicenter and on the slopes facing northwest and the opposite slopes facing southeast in the mountain terrain around the Bantul District, which suffered serious damage caused by the collapse of houses (Photo 5.2).

**Photo 5.2: Failures in the mountains east of the Bantul District**

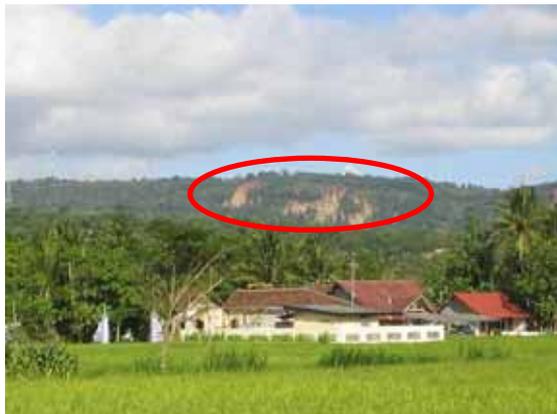
**Photo 5.3: Failures on cliffs**

The slopes facing north in the vicinity of the borders between the Bantul, Sleman and Gunungkidul Districts about 20 km north-northeast of the epicenter, where the mountain terrain bends eastward, have many failures on cliffs of the cuesta topography (Photo 5.3). In the Jatikuning area of Ngro-oro Village, Gunungkidul District, in particular, large-scale failures have been found (Figures 5.1, 5.2). These failures have occurred at intervals in an area of about 700-800 m wide from the knick lines at about 320-330 m above sea level on the series of near-vertical cliffs in the east-west direction of about 100 m in relative height on the north slopes of the mountains (Photo 5.4). They are rock or surface failures, which are likely to have been caused by the collapse of the bedrock in blocks from the joint due to the earthquake motion. The geology seems to be mostly tuff breccias in strata of opposite dip. Immediately below the slopes are sediments of rocks of about 4-5 m and the collapsed soil has been deposited immediately below the slopes in spite of the relative height of about 100 m. This is presumed to be because of

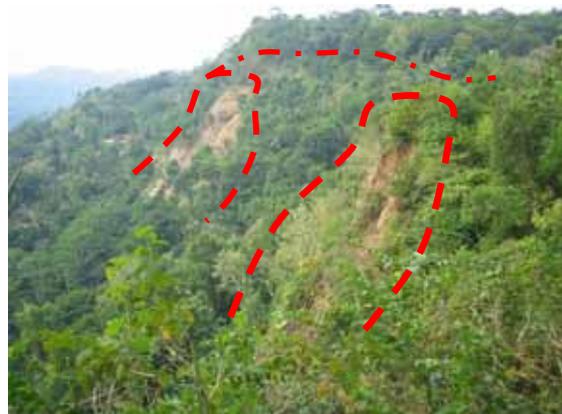
**Photo 5.4: Failures in series**

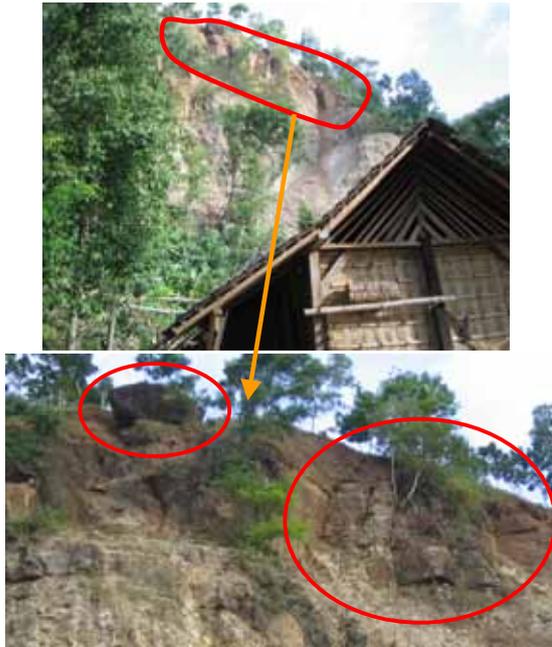
the low moisture content of the soil due to the dry season, which spared the houses below the slopes of direct hit of the collapsed soil. However, unstable, overhung banks and large masses of rocks still remain (Photo 5.5) and numerous cracks are found in the fields in the upper part of the slopes or on the neighboring slopes (Photos 5.6, 5.7), which indicates an extremely high possibility of larger-scale collapse in the rainy season. Despite the danger posed by these conditions, residents still remain in a settlement directly under the slopes (Photo 5.8).

**Photo 5.5: Collapsed soil in unstable conditions**

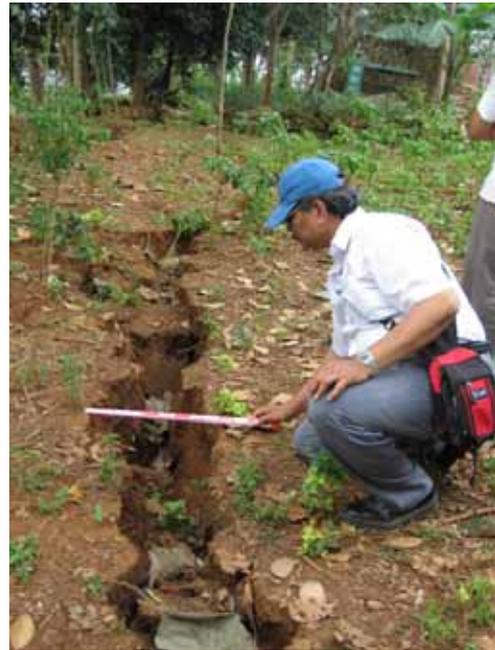
**Photo 5.6: Crack on slope**

- 2) Any identified crack must be filled or treated for preventing infiltration of rainwater (by covering with plastic sheets) as emergency measures. In addition, monitoring with instruments such as strain gauges and visual observation, the development of the channel of information to notify the residents of the results, the establishment of the emergency evacuation system, etc. are required.

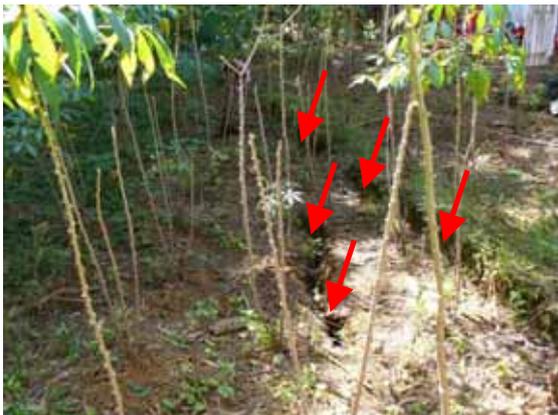
**Photo 5.7: Cracks found in field on plain in the upper part of slope**

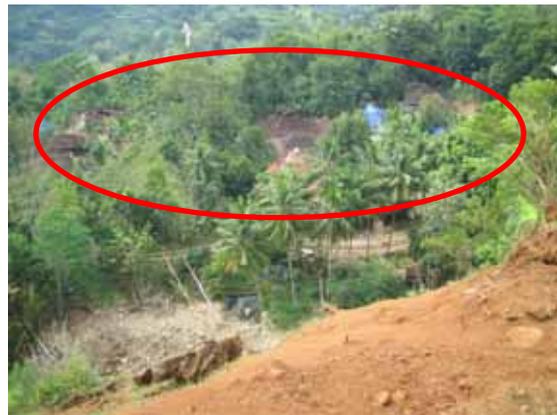
**Photo 5.8: Settlement below overhung collapsed slope (about 100 m high)**

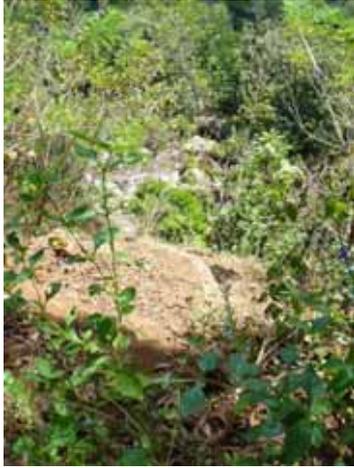
In the Pandeyan area of Semoyo Village, Bantul District, located about 5-6 km southwest of these slopes, rock falls have caused one death (Photo 5.9) and damage to a house (Photo 5.10).

**Photo 5.9: Site of fatal rock fall**

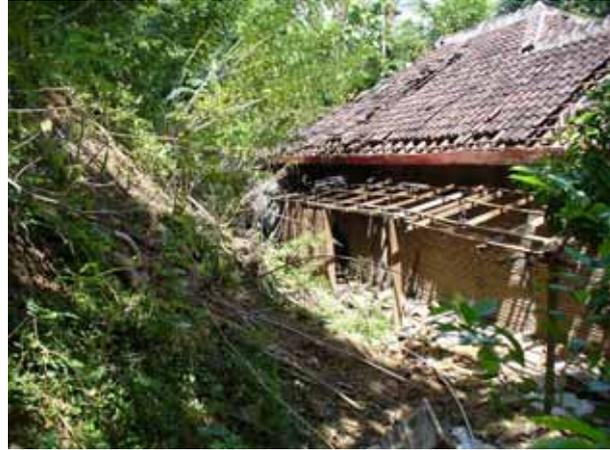
**Photo 5.10: House damaged by rock fall**

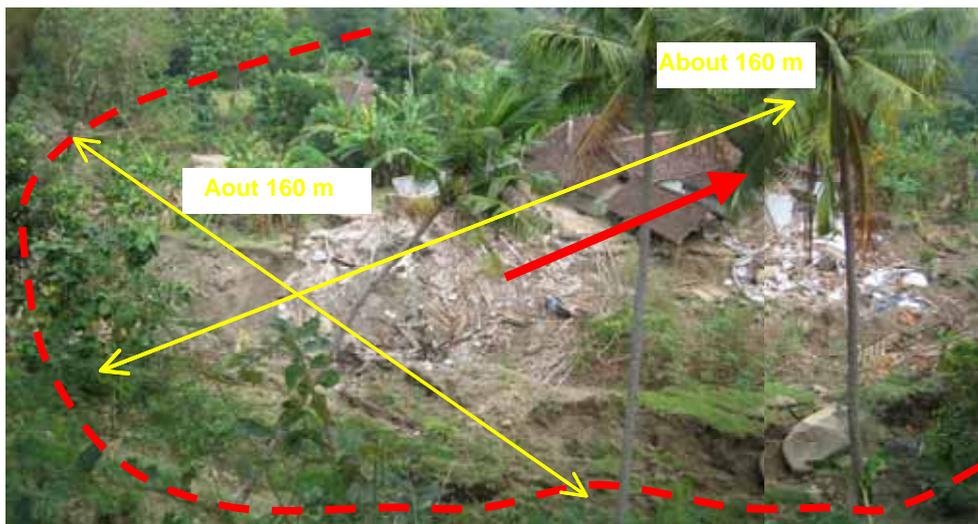
In the Nglepen area of Sumberharjo Village, Sleman District, about 3 km north from the slope failure hazard area of Jatikuning, the earthquake has caused a large-scale landslide (Photos 5.11, 5.12).

**Photo 5.11: Landslide area seen from the upper part of the scarp**

- 4) Equipment and measuring instruments required for studying hazardous slopes (strain gauges, etc.) must be provided.
- 5) Regarding the landslide in Sumberharjo, Sleman District, filling of cracks as an immediate measure for preventing rainfall supply through the cracks to the landslide soil mass and surface runoff draining by temporarily cutting unlined tunnels for preventing flooding of large-scale depressions generated directly below scarps and rainwater infiltration into other cracks are considered required.

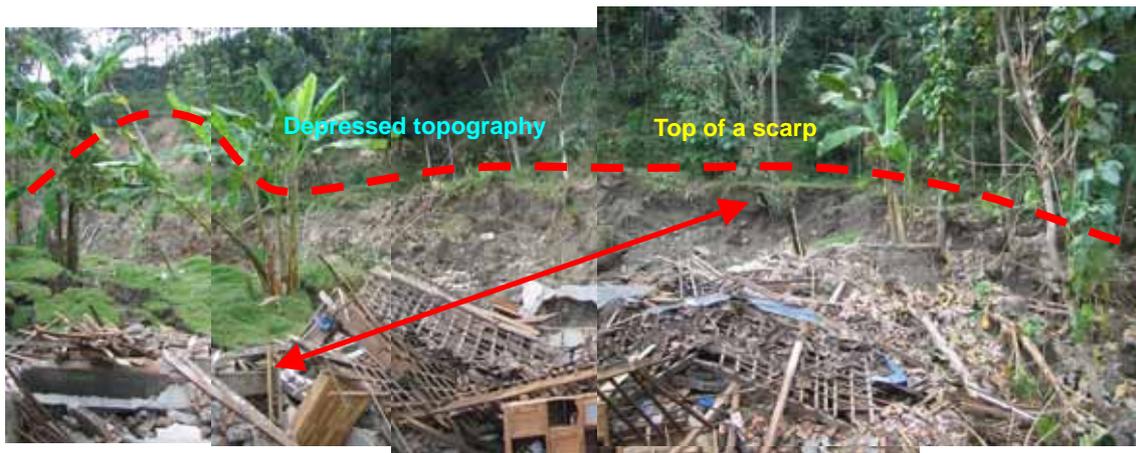
While the slope failures have occurred on the cliffs on the north side of the cuesta topography, this landslide has occurred on the gentle slopes on the south side. The surrounding topography is in a horseshoe shape and the earthquake is considered to have reactivated old landslides. The geology can be characterized by alternate layers of mudstones and tuffs and is presumed to be a dip slope based on the conditions of the bare rocks in the surrounding area. With the sliding surface unexposed, however, the properties or location of the sliding surface have not been identified. The scale of the landslide is about 160-170 m in scarp width, 5-6 m in scarp height and 160 m in entire length of landslide block. In addition, a depressed topography of 30-40 m wide has been generated along the scarp, into which a few houses have been found fallen to be completely destroyed (Photo 5.12).

**Photo 5.12: Situation of the landslide area**

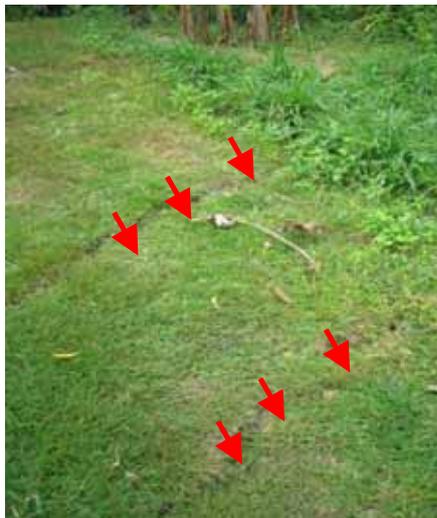
**Photo 5.13:  
Cracks in a landslide area**

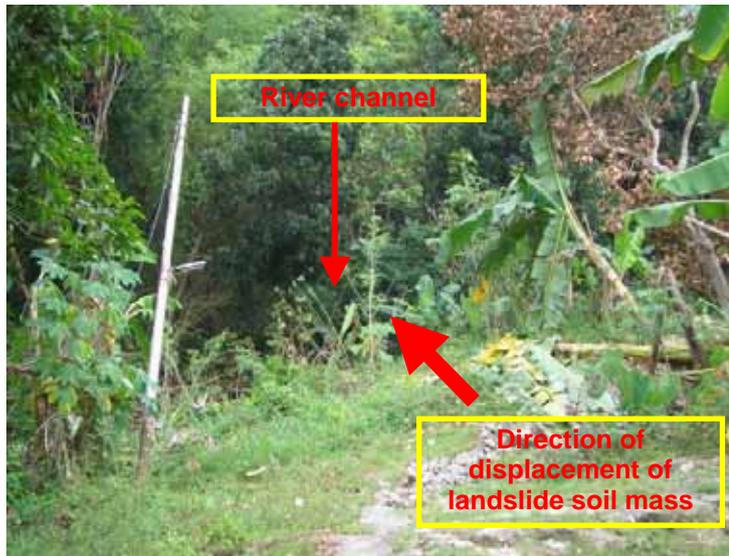
Although all of the 13 houses in the landslide area have been damaged, six of which completely destroyed, fortunately nobody has been killed or injured. However, resettlement is difficult and all of the residents are reportedly planning to relocate. Based on the interviews with villagers, the landslide occurred immediately following the earthquake, which caused the soil to slide approximately to the current position and continue to be displaced for about ten minutes. No water discharge, etc. has been found as of the time of the investigation and there is little possibility of abrupt slides anytime soon but many cracks have been observed in the landslide area (Photo 5.13), which indicates high risk of further displacement in the rainy season. In addition, the distal end of the landslide has extruded towards the valley, posing danger of blocking the river channel (Photo 5.14). This may break and flow down as a mudflow to the settlements downstream in the rainy season, causing damage.

**Photo 5.14: Distal end of landslide area**

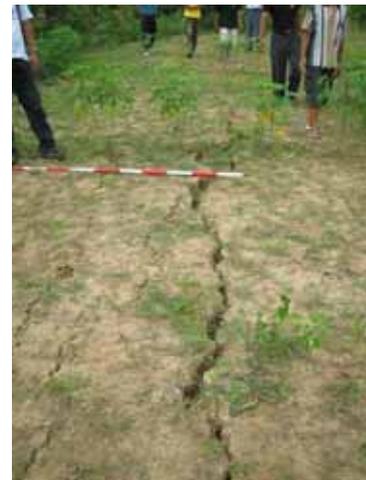
Furthermore, a series of cracks of about 100 m in total length has been found in the flatland (fields) above the knick lines of the cliffs in the Pantuk area in the upper part of the mountains in the vicinity (Photo 5.15). On the lower part of the slope is located the Pereng area with about 90 households. The residents of the settlement are not informed of the cracks in the upper part or the hazardous condition and not aware of the danger.

**Photo 5.15: Condition of cracks**

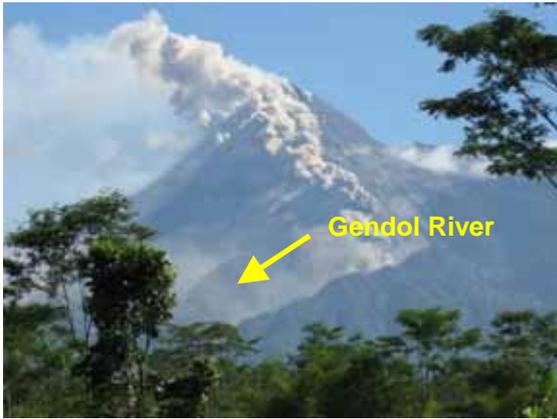
**Photo 5.16: Pyroclastic flows into Gendol River**

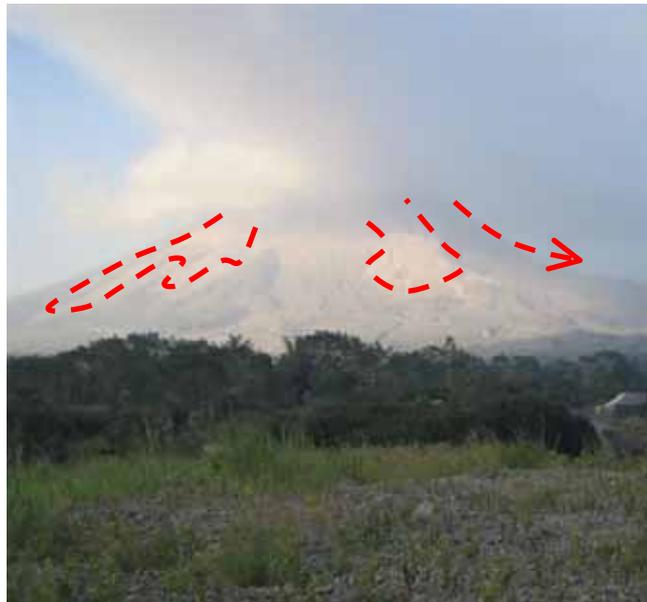
**Photo 5.18: Directions of pyroclastic flow deposition: Blongken River on the left side, Kuning and Boyong Rivers on this side and Gendol River on the right side**

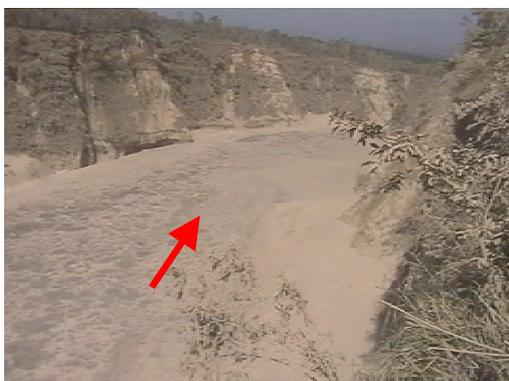
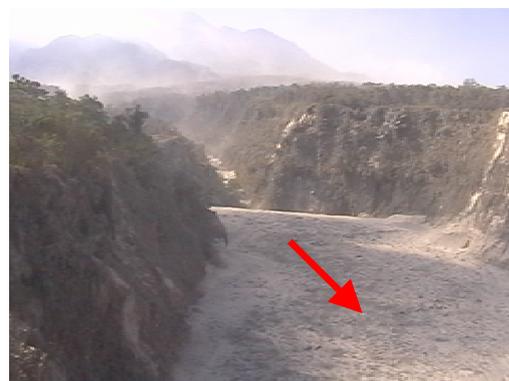
After our study has been completed, a large-scale pyroclastic flow towards Gendol River occurred on June 14 that reached a point 7 km away from the crater (1,000 m above sea level) causing two deaths and a heavy pyroclastic flow deposited in Gendol River as well (Photo 5.19). Although the deposition thickness has not been accurately identified, the deposition distance from the crater points to a considerably large volume of pyroclastic flow deposits. This heavy deposition of pyroclastic flows in the river channels increases the risk of massive mudflows in the rainy season.

**Photo 5.19: Pyroclastic flow deposits in Gendol River (source: Sabo Technical Center, Directorate General of Water Resources, Ministry of Public Works)**

- 2) In rivers with the risk of mudflows, it is necessary to discuss in advance the non-structural measures including emergency debris removal, bank raising and training dike construction by checking the available capacity of sabo dams, dams allowing debris removal, conveyance routes/disposal areas and the points requiring training dikes. These emergency plans must be implemented in preparation for possible mudflows in the rainy season.
