**Nepal Government  
Ministry of Irrigation**

**Report on  
Jure Landslide, Mankha VDC, Sindhupalchowk District**

The Report based on the Study committee formulated by  
Ministry of Irrigation (Minister Level) on August 24, 2014 AD (2071/05/08 BS)

**September 21, 2014 AD  
(2071/06/05 BS)**

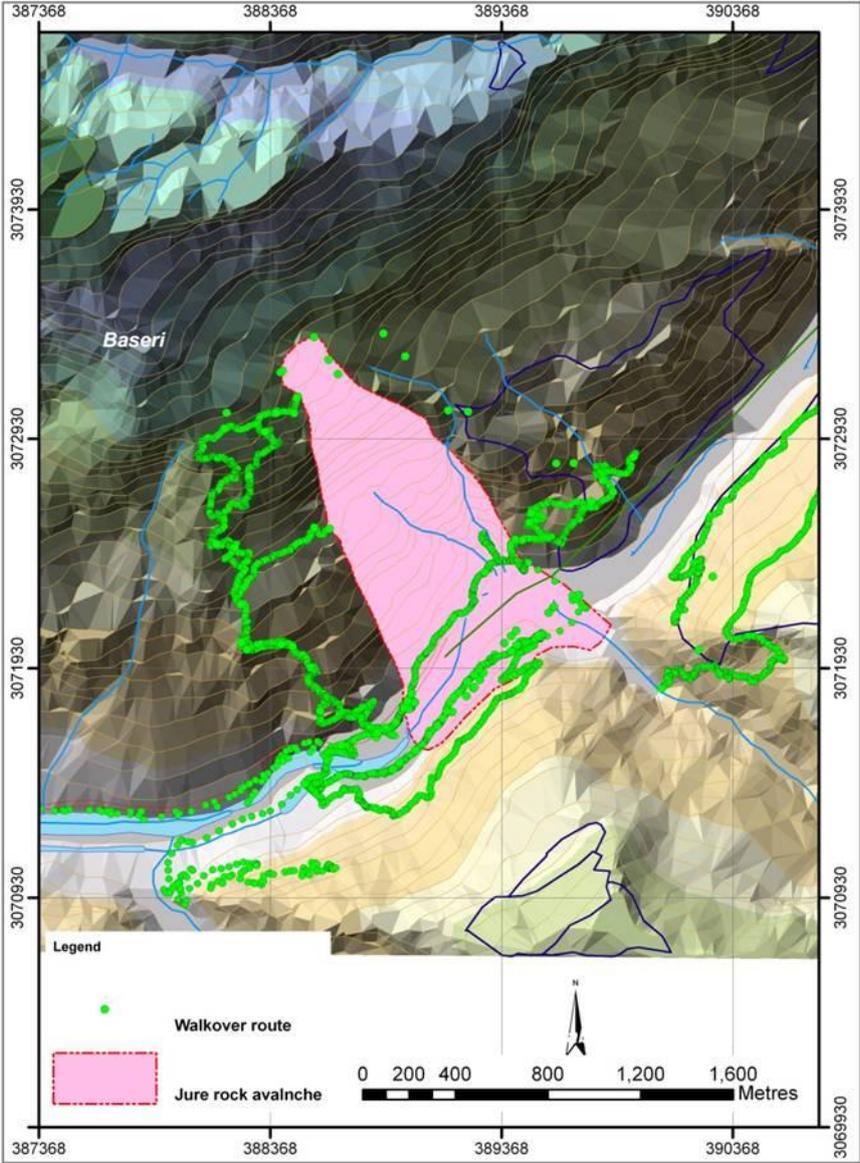
Figure 1: GIS map showing Tracks and Location of study points during the Jure Landslide study, Sindhupalchowk.

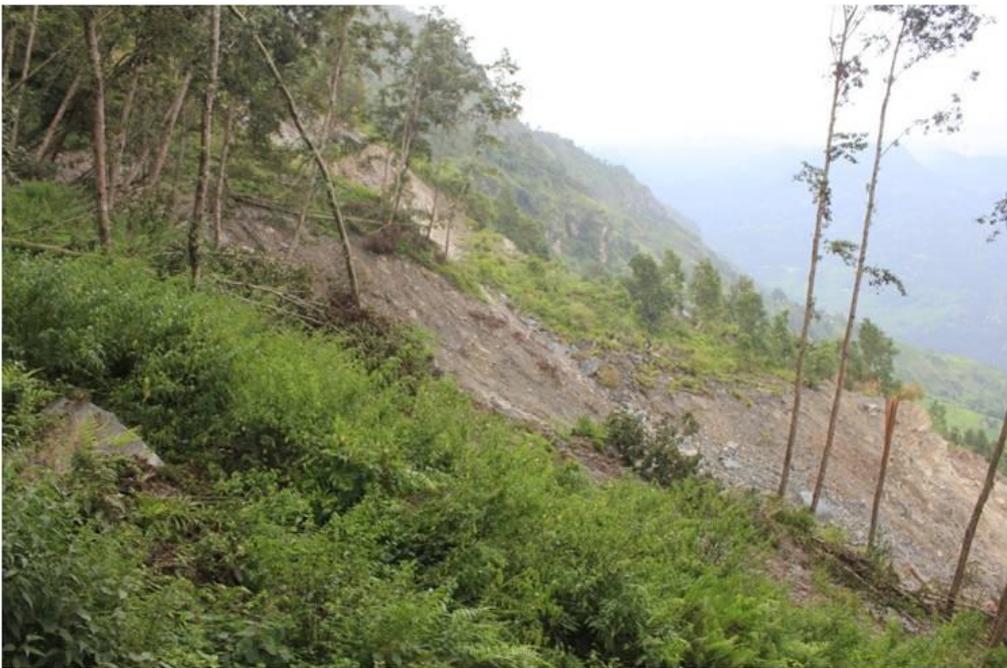
**4.1 Crown Part:** The altitude of the crown part of the landslide is about 1650m msl. The land surface in the crown part is still in unstable condition. There are present of many cracks, spring water is coming out, different blocks are moving and toppling down from the cracks, trees are tilting down to different directions and about 300m width and about 15m depth body mass are in process to move or slip down slowly. (Figure 2,3,4,5 &6). It was noted that the surface water was flowing into the cracks developed in the crown area

near the Tate village since 2 years and the location was descended with some kind of sounds just two days before the disaster event. In the mean time, the villagers were shifted from that location to safe site before two days knowing such a hazardous condition of the site. The landslide in the crown part was initiated at about 5Am in that day as per the villagers. The village road near the Tate village also was damaged by the landslide event (fig.5) but it is now maintained by the villagers. The villagers of the Tate village mentioned that the crown part area of the landslide was in risky condition since long time ago.

Figure 2: Cracks and disturbed surface in the Crown part of the Jure Landslide

- a) The landslide and debris flow in the Head part of the Jure landslide is still active. So first of all the water available in the crown part should be managed by diverting to another safe side. The landslide and debris flow countermeasure work should be done.
- b) About 100m from the Landside boundary should be warned as Hazardous area. Any type of land uses as Residence, Irrigation and so on should be stopped at the moment.
- c) The unstable part in the Crown part of the landslide should be removed and water management should be done in this area.
- d) The weathered and unstable cliffs with cracks in the shoulder should be trimmed.

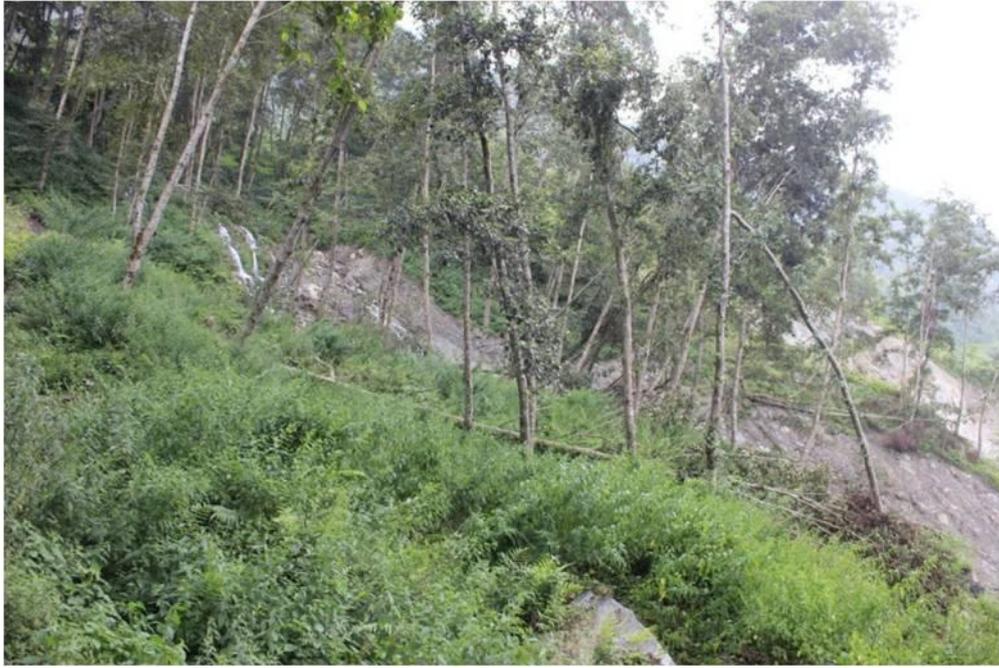
Figure 3: Disturbed and inclined trees in the crown part of the Landslide

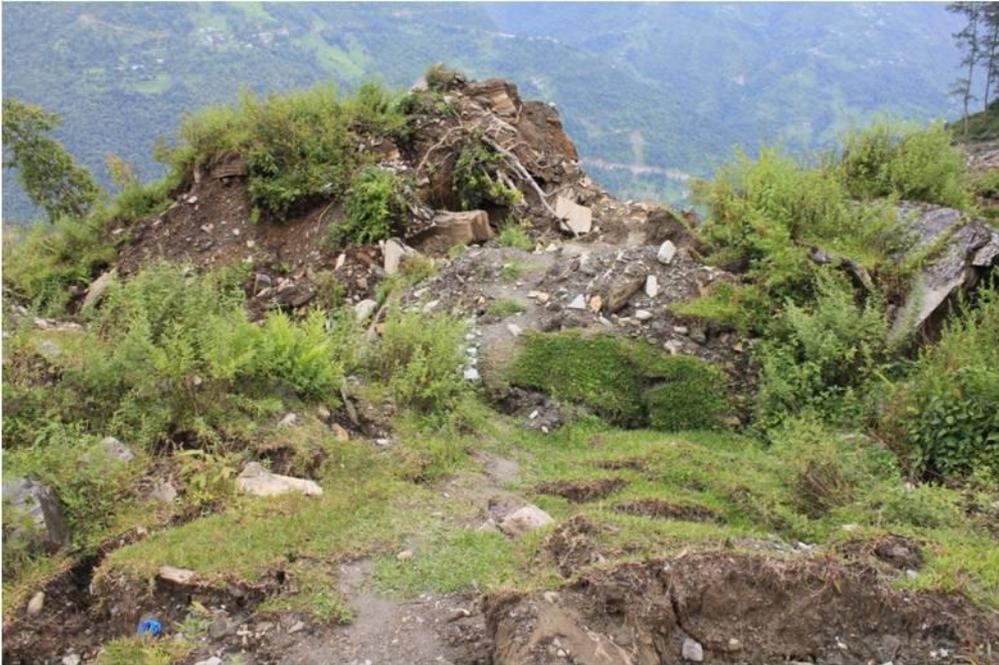
Figure4: Cracks and ready to move mass in the Crown part of the Landslide

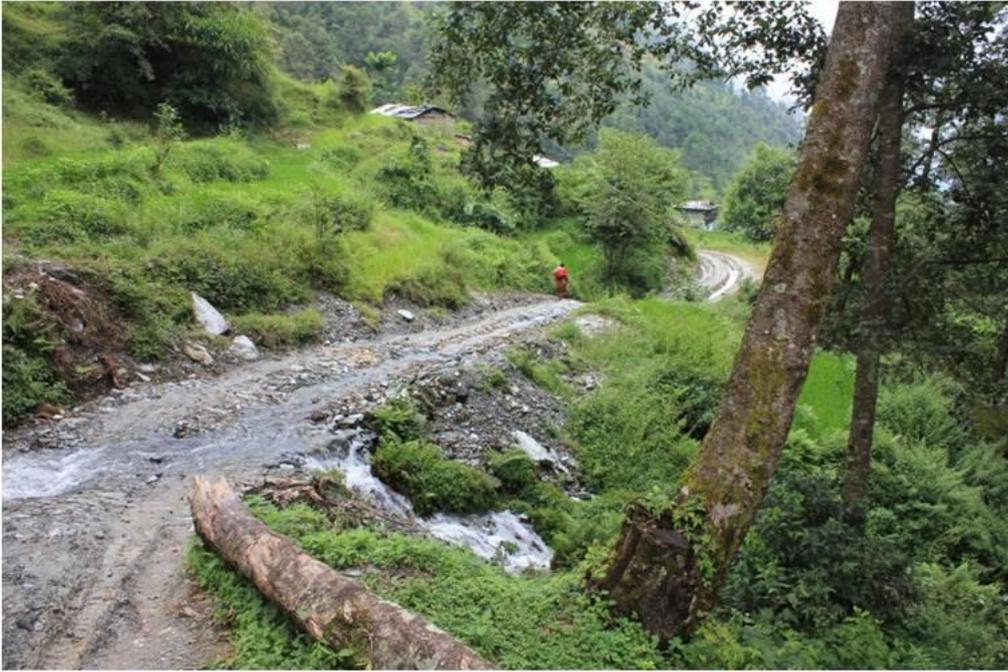
Figure 5: Subsided village road in the crown part of the Landslide

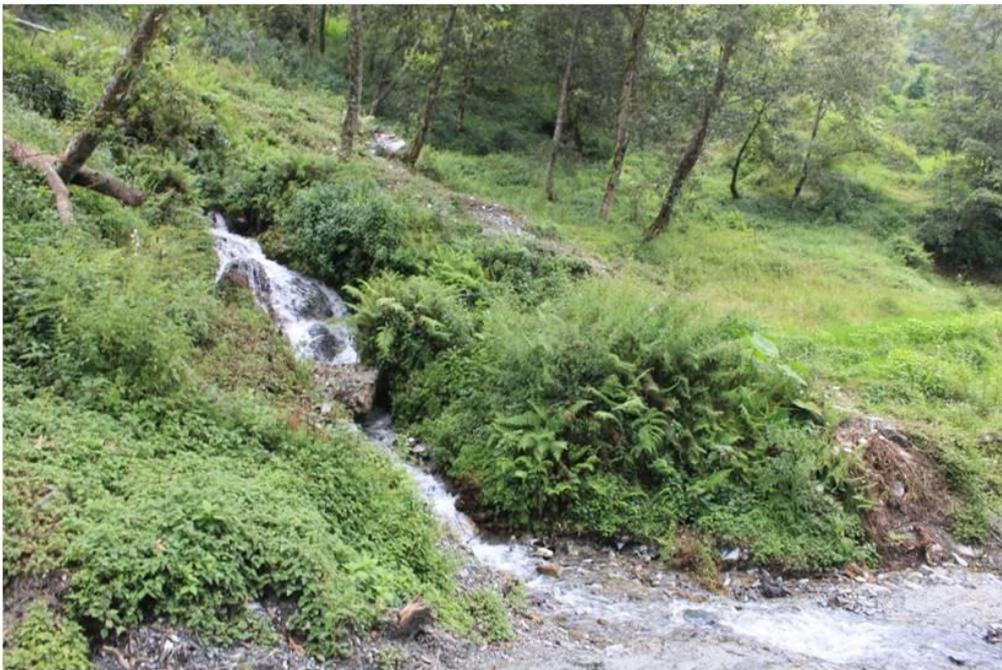
Figure 6: Streams flowing at the Crown part of the Landslide

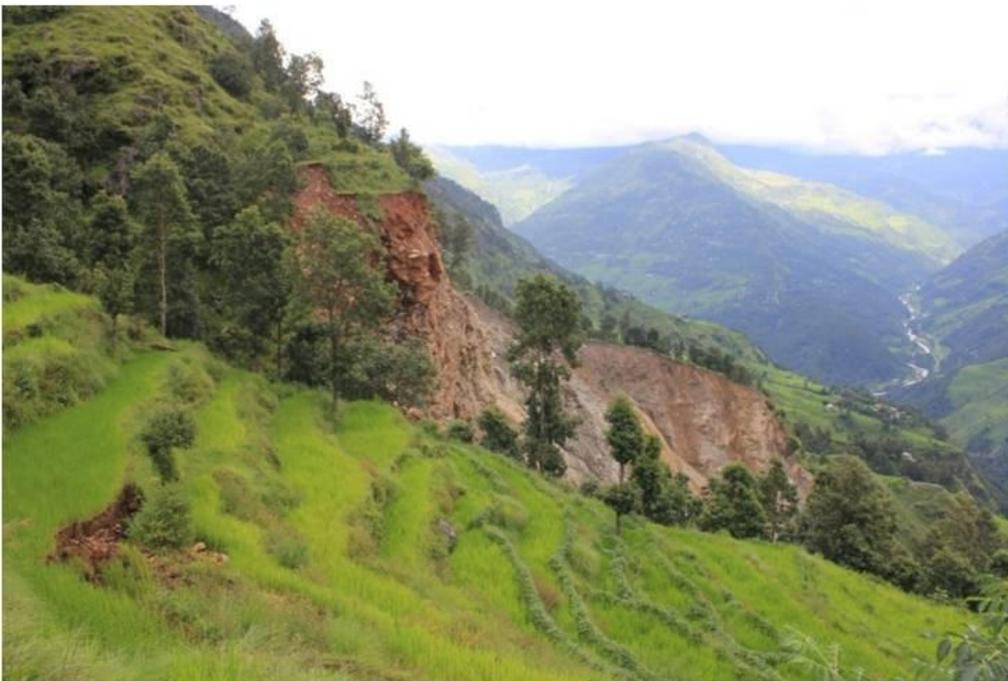
**4.2 Crown part to near the Iteni village:** There is still existence of large cracks, huge rock boulders and fragments, springs in many places in this area. Debris is flowing down. The slope of this area is much steep (fig 7 &8). Still it can be observed the falling of the rocks from the crown part. The weathered rock bridge (shoulder of the landslide in centre part) about 200m thick is made up of black pyllite and quartzite but in the site it is seen as grey and yellowish in color. These conditions of the rocks are due to the interaction of water and chemical weathering since long time back. It is most probable to rock fall, topple and debris flow in this area in near future due to existence of sufficient spring water and fractured rock debris.

Figure 7: Hanging block at the upper boundary part of the Landslide

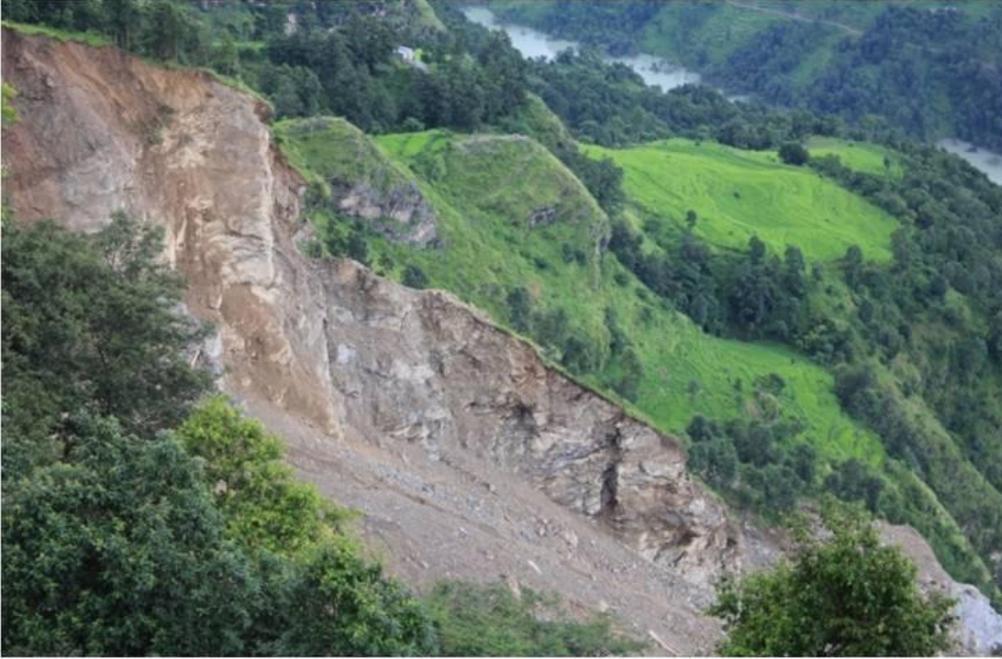
Figure 8: Big cracks near the border of Landslide

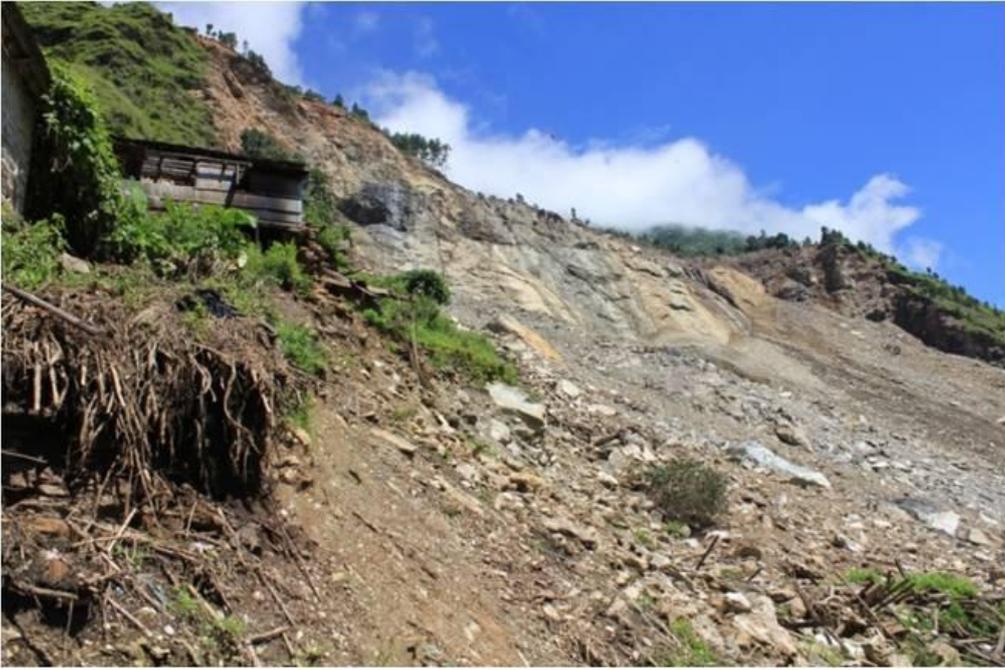
**4.3 Nearby the Iteni village part:** There is a comparatively hard rock bridge (shoulder) about 100m down from this area where debris fan is deposited about 20-25m span. There are some huge rock boulders/fragments of about 3m\*3m\*2m size which are in high hazardous condition that could be fell/roll down any time. In this place, the debris is still flowing down continuously. Here the part of the Iteny village is completely damaged (fig 9, 10, 11).

Figure 9: Landslide near the damaged village Iteni

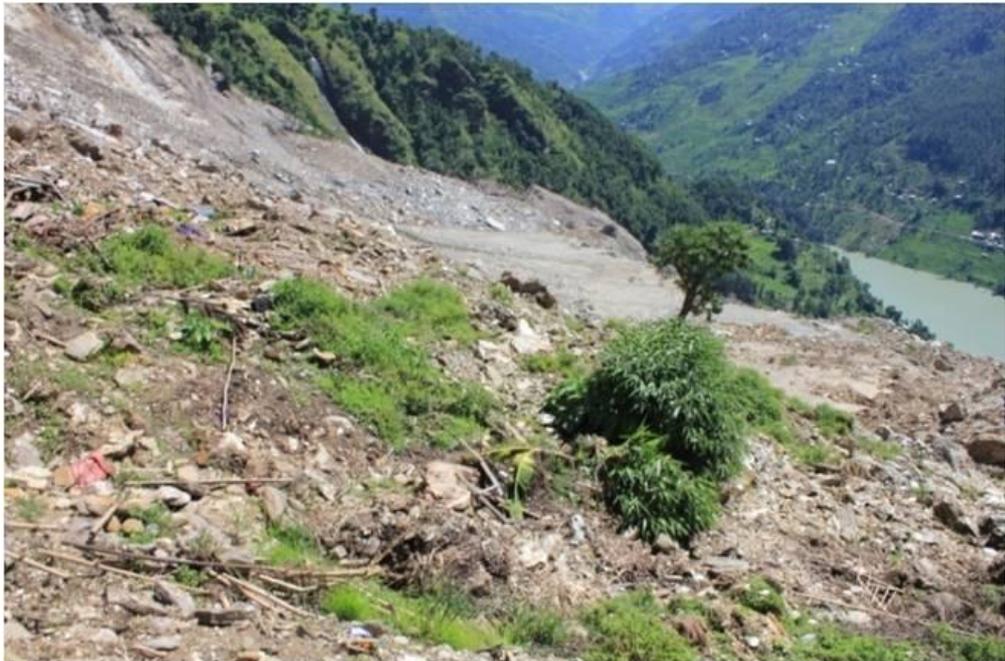
Figure 10: Landslide block moving down near the Iteni Village

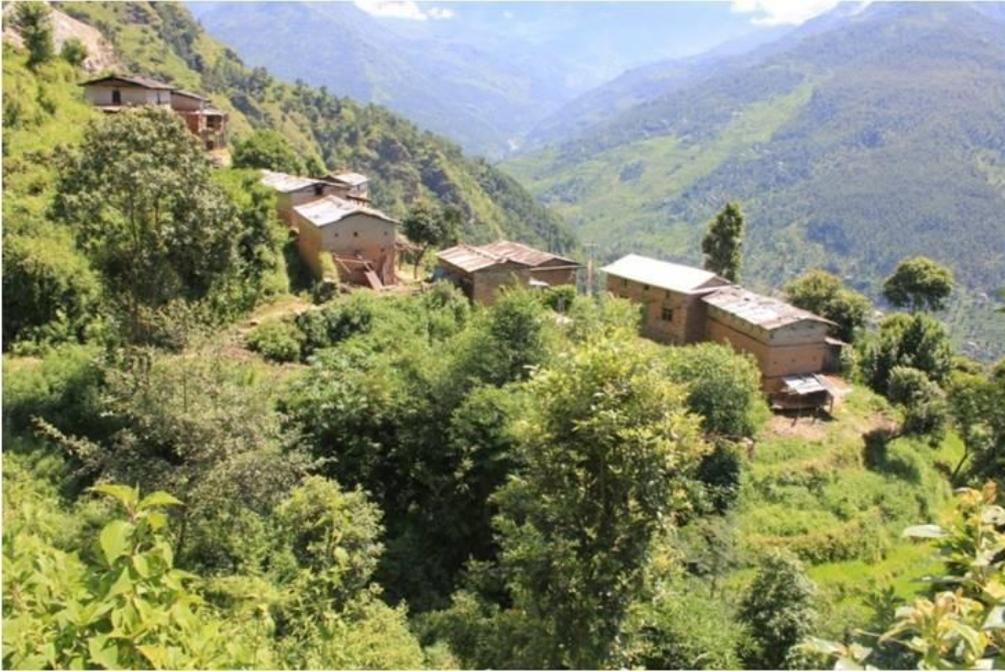
Figure 11: The vulnerable remaining part of the Iteni Village

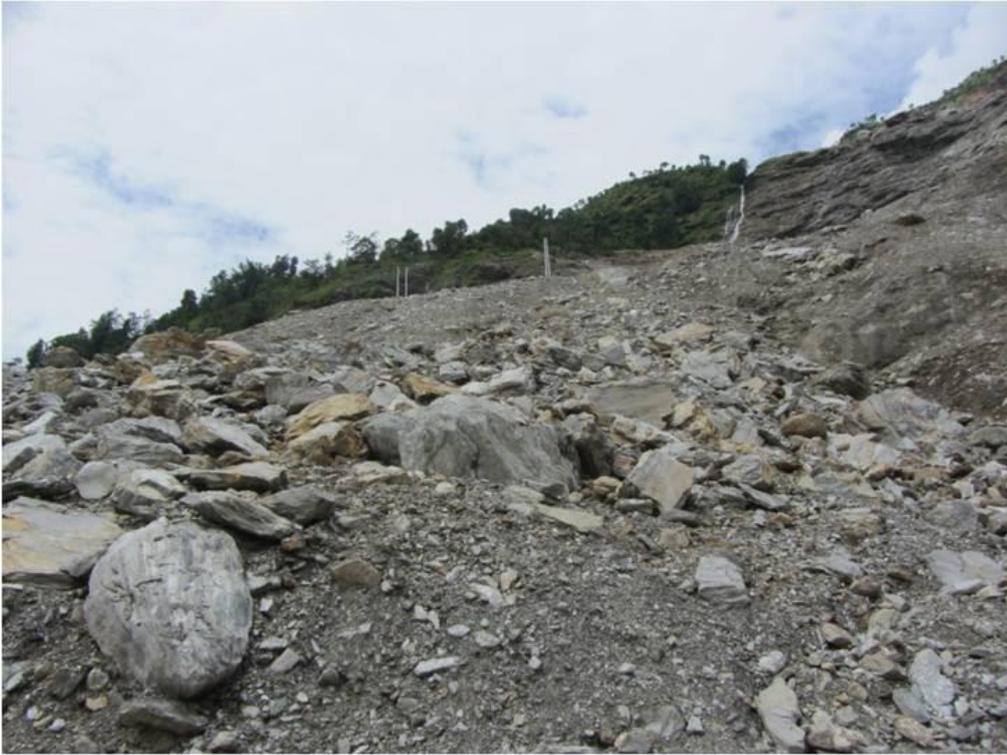
**4.5 Toe or debris fan deposit area:** This area is the toe part of the Jure landslide. The debris and rock fragments fallen from the upper part are deposited in this area as fan deposit. This area is about 800m width, about 300m high and about 25-50m depth. The temporary road track is excavating from Eastern side of this area. This area is much more vulnerable due the continuous falling of rock fragments and the debris flow. New slope failures, sinking of surfaces and sink hole formations are increasing due the bank cutting along downstream by the Sunkoshi river. The disaster event damaged the houses existed in this area and Jure bazaar completely and damaged two gates of Sunkoshi powerhouse barrage including about 1km long Araniko Highway. At present, some electric poles are installing by Nepal Electricity Authority in this area.

Figure 12: Debris deposited at the toe part of the Landslide

- e) The newly track road is aligned through the toe part of the landslide where the probability of rock falling and debris flow is high. So the protection wall in upper part of the road and scouring by Sunkoshi in the lower part of the road should be protected.
- f) Geophysical and Geotechnical study of the Jure Landslide is recommended. As per the study report the mitigation measures of the landslide should be done.

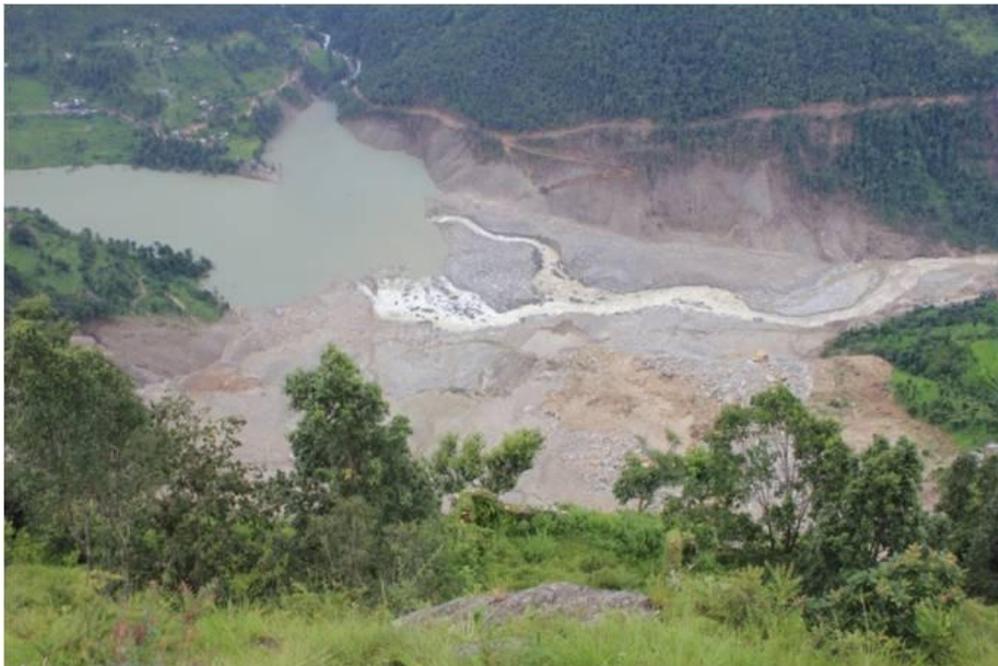
**4.6 Landslide Natural Dam in Sunkoshi:** The length of the dam across the river was measured about 350m, the width of the dam along the river was measured about 700m and the height of the dam was about 55m. The primary channel for outlet of the trapped river was opened on August 2, 2014 at about 2pm by Nepal Army with the help of experts from Department of Water Induced Disaster Prevention DWIDP. The opening method of the channel was mainly blasting but the rock type of this area is mainly schiest and phyllite, due to which it was felt difficult to progress the deepening of the channel. In this stage the experts and decision makers in the special committee formulated by Ministry of Home Affairs decided to open secondary channel. The experts located the secondary channel at middle part of the dam to open. Thus the secondary channel was opened on August 30, 2014 in the morning at central part of the dam by Nepal Army with blasting and excavation by two numbers excavators. In the same way, Nepal Army excavated the approach road to the dam site. The Nepal Army continued to widen the inlet of the secondary channel upto 52m wide on September 6, 2014. Rainfall in the watershed was occurred in the night of September 6. Due to more widening of the inlet of the secondary channel and occurrence of rainfall in the watershed, the dam was pressurized by water and hit and scour in the weak part of the dam. In the result the dam was breached on

September 7, 2014 at 1am and continued up 4Am (Fig. 13 and 14). Since the breaching occurred slowly and it took about 4hrs, the damages by the breach were nominal and no casualties. The Department of Hydrology and Metrology recorded the discharge during the breaching of the dam at Pachuwaghat real time gauze station which was located at downstream from Khadichaur Bridge. As per the record, the normal flow was 300 cu.m/sec and the maximum discharge was 1350 cu.m/sec and the historic capacity of channel was 1700-1800 cu.m/sec. So the maximum flow was within the capacity. After the breaching of the dam, the water level in the reservoir was decreased by 20m. The study Report of Hazard Mitigation in the Northern Sunkoshi and Bhote Koshi Water Catchment Areas, Nepal (HMWA), 1996 reported that under the Natural dam, the River terrace of sand, clay and gravel boulders were existed.

Figure 13: Opening of Secondary Channel in the Landslide Dam

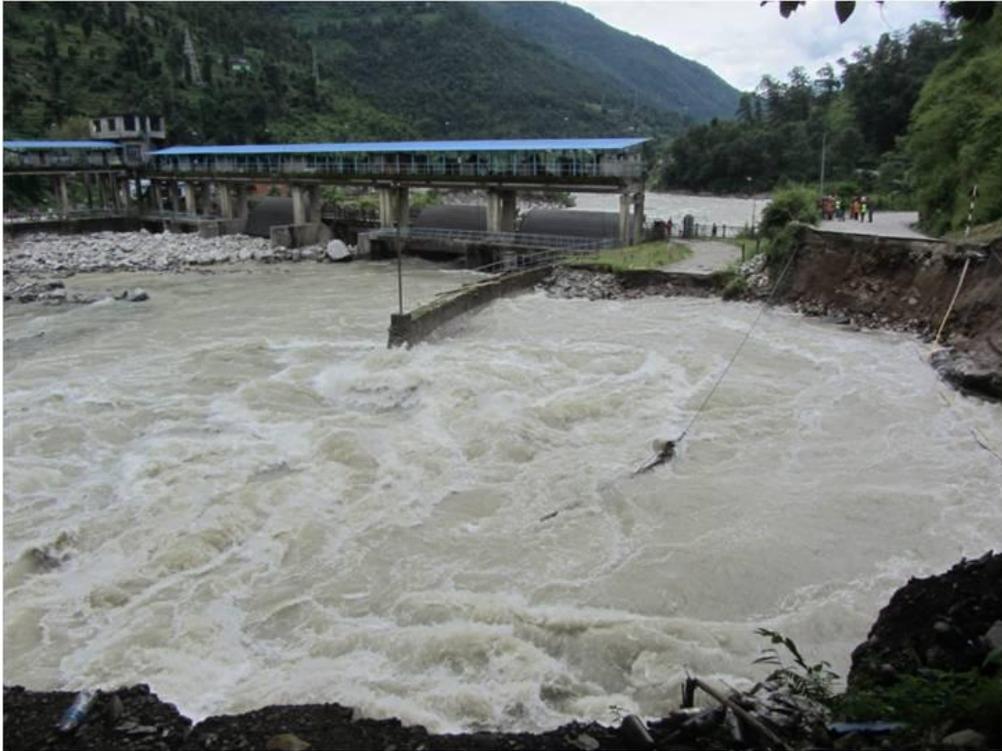
Figure 14: Damaged Sunkosi Hydropower Headwork and Araniko Highway after breach of the Landslide Dam

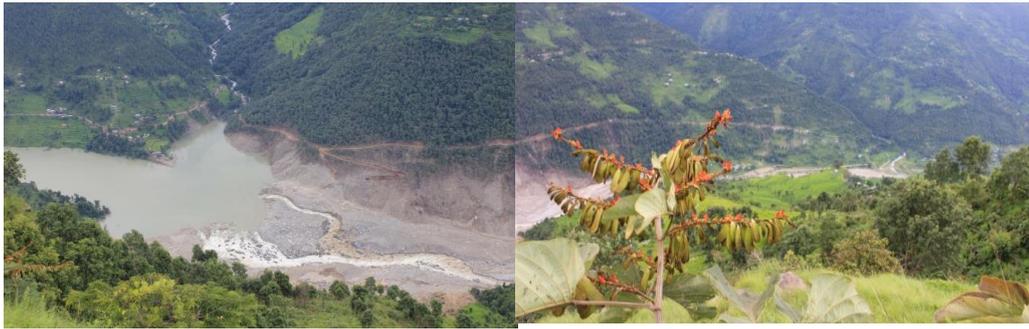
The temporary village road excavated by Nepal Army in the left bank of Sunkoshi River is still in operation (Fig 15). In this road, Nepal Army installed a belly bridge in Sukoshi River near the Barhabise Bazar.

Figure 15: The alternate temporary road to Barahbise constructing by Nepal Army

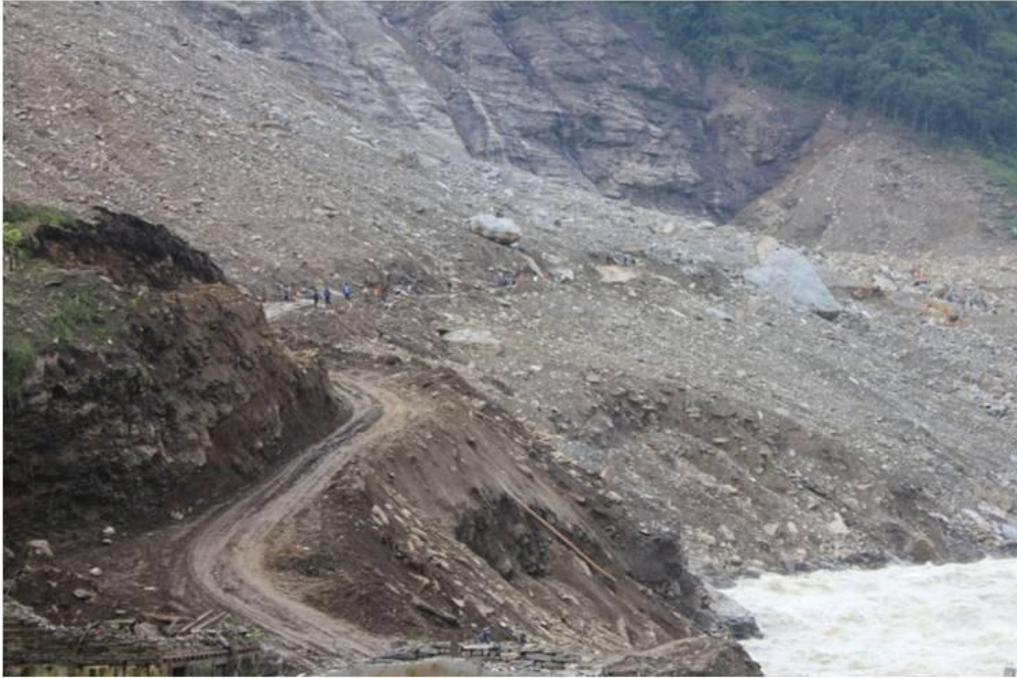
Photo 1: Temporary Araniko Highway track at toe of the Landslide

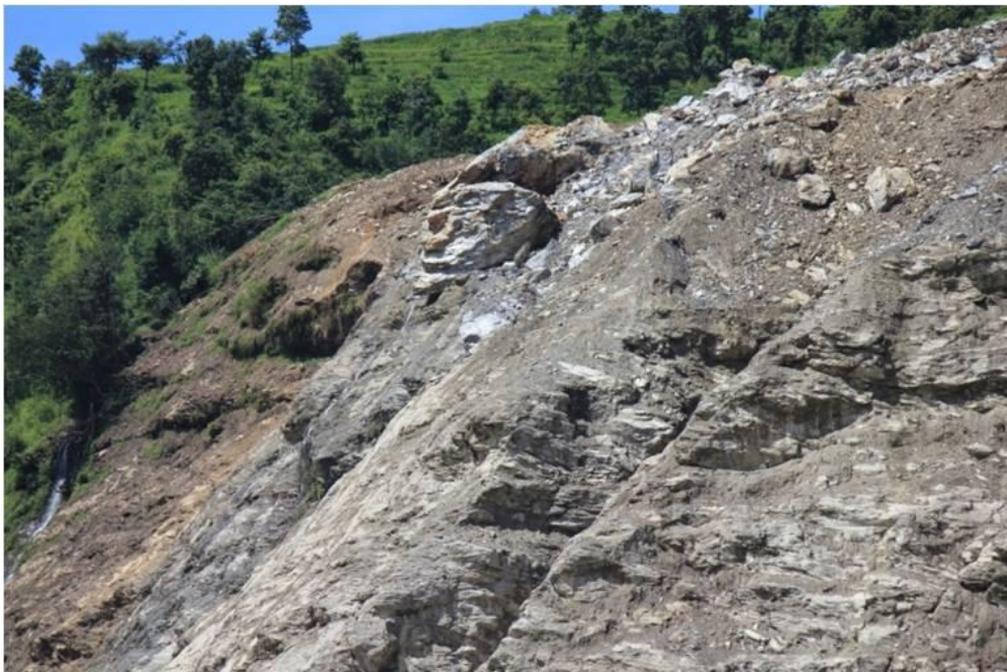
Photo 2: Big rock boulders fallen from the Landslide

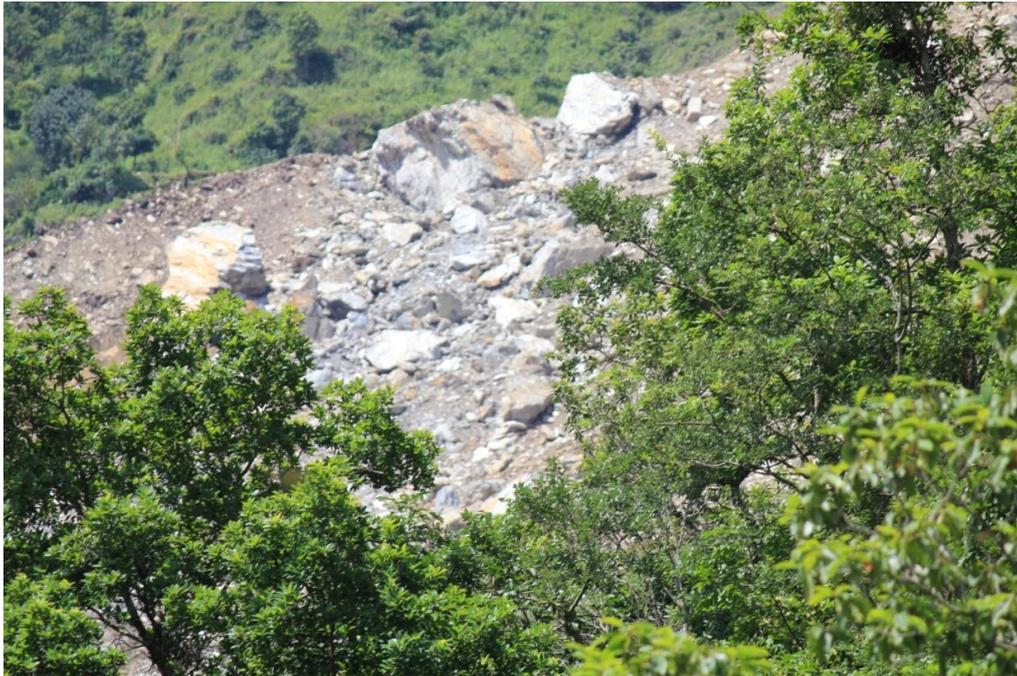
Photo 3: Rock fragments fallen from the Landslide

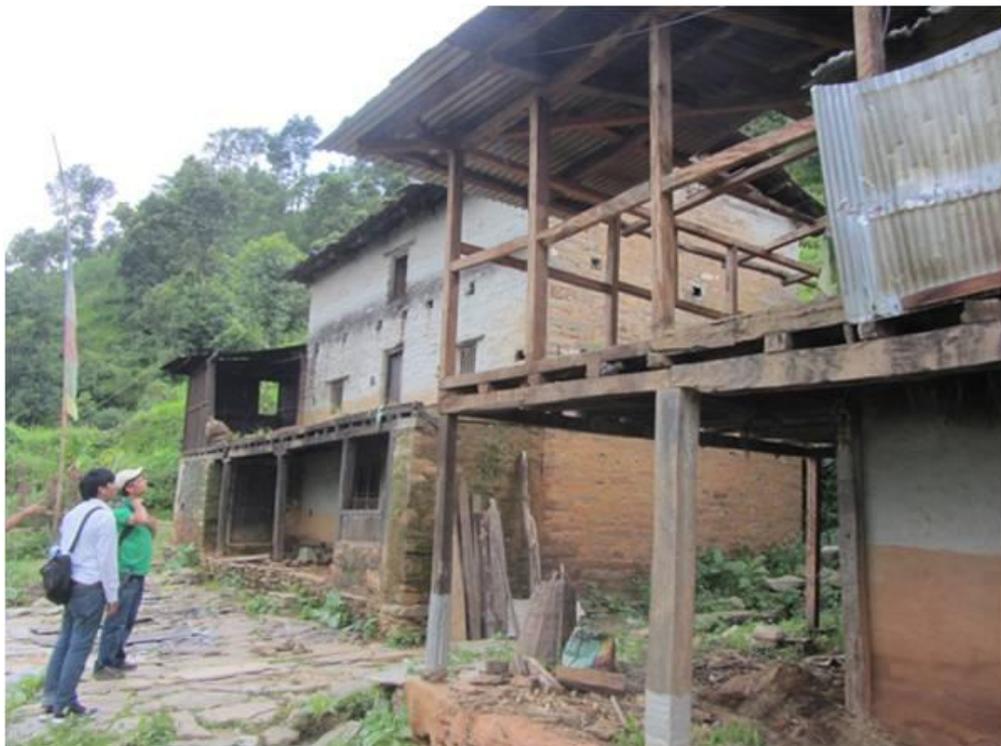
Photo 4: Damaged houses due to the Landslide

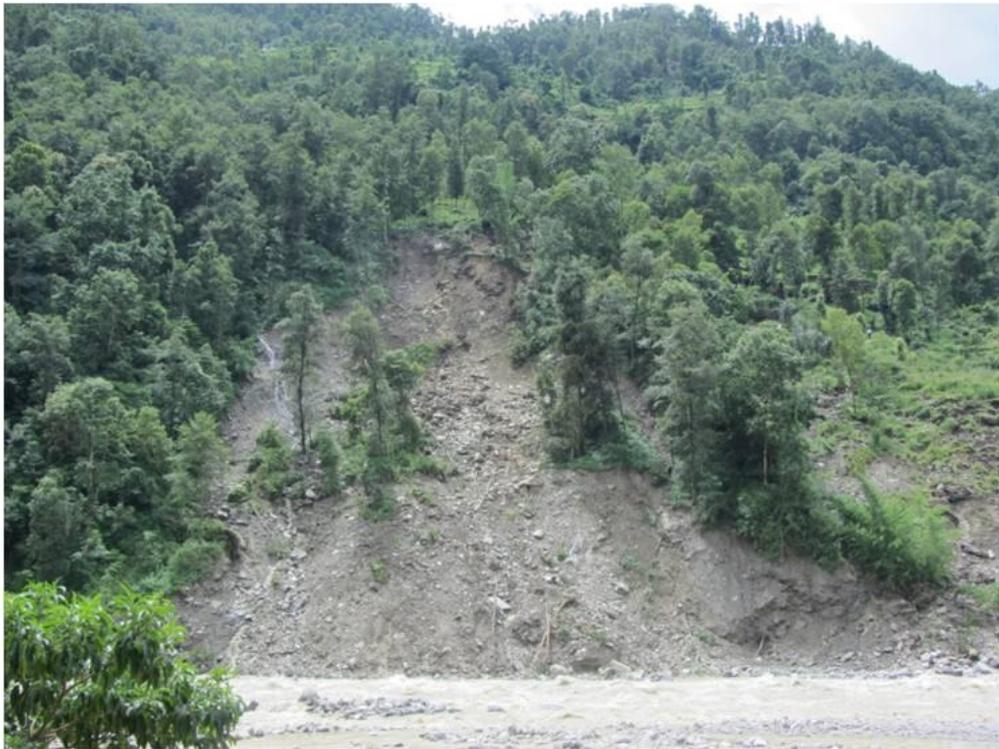
Photo 6: Landslide occurred at left bank of Sunkoshi after breach of Dam
