Field Survey of Typhoon Reming (Durian)-triggered Mudflow Disaster at Mayon Volcano in the Philippines

Takeo Mitsunaga(JICA long-term expert in Philippines), Ryosuke Tsunaki(National Institute for Land and Infrastructure Management, MLIT), Wataru Sakurai(Public Works Research Institute), Hidehiko Manzen(Sabo Technical Center)

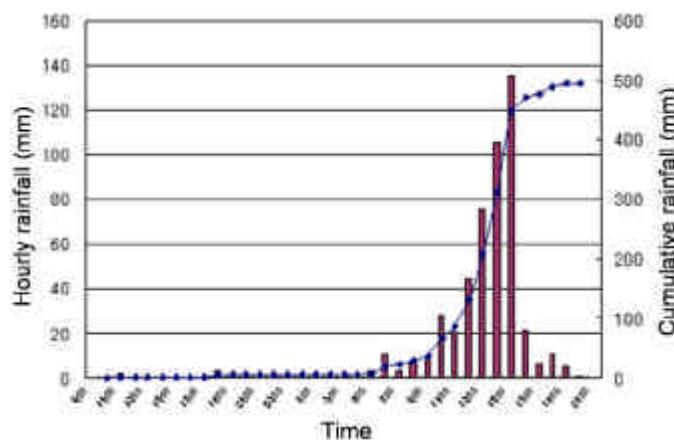
On November 30, 2006, a severe typhoon hit the area with a torrential rainfall of 466 mm (Fig. 2), which was far exceeding the past maximum daily rainfall of 370mm recorded in 1967. It triggered a large-scale mudflow over the wide area between the eastern and southern slopes of this volcano (Fig. 3). The resulting damage was disastrous, the dead 620 (734), missing 710 (762), injured 1,478 (2,360), totally collapsed houses 89,474 (228,436), and partially collapsed houses 71,338 (359,601). (The number without parenthesis shows the damage in Albay Province disclosed by the National Disaster Coordination Council (NDCC) on December 16. The number in the parenthesis shows the damage in the entire Philippines. It was confirmed through the hearing of local governments that the most of the damage in Albay Province was caused by the mudflow).

Fig.2 Rainfall at Legazpi City

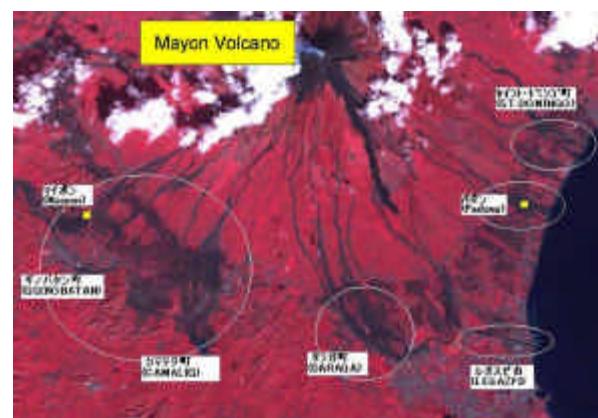
Fig.3 Mudflow(debris flow) at the foothills of Mayon Volcano(The flooding areais shownin black)

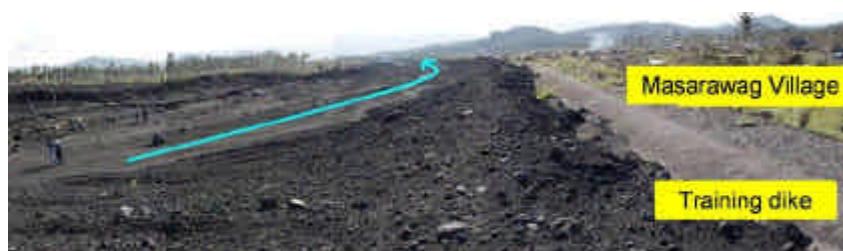
At the disaster site on the foothills of Mayon Volcano, some villages could escape from damage owing to the training dike installed in the past (Photo 1), but other villages such as Padang on the eastern foothills, Busay on the southeastern foothills, and Maipon on the southwestern foothills were covered with a 2 m-deep mudflow over the width of several hundred meters. In these villages, only the roofs of houses remained above the debris and it was like “The entire village was swallowed by the mudflow and the former landscape is unimaginable” as one villager grieved. Large sized boulders, 2 ~ 3 m in diameter, were found in the deposited debris (Photos 2 ~ 7).

Photo.1 Damage was alleviated by training dike.

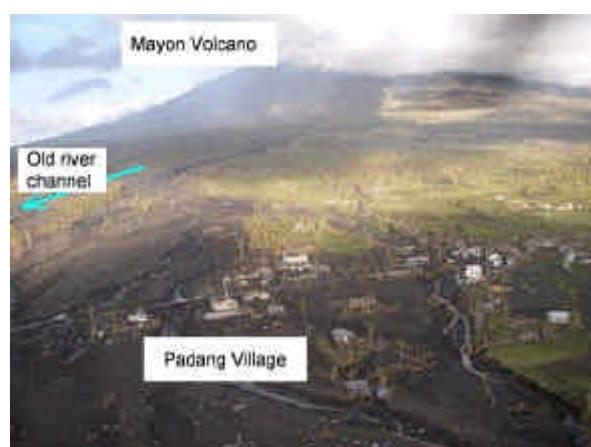
Photo.2 Damage at Padang Village(1)

People in Padang Village never thought of being involved in a debris flow, because their village was 300 m away from the river and the lower part the river channel was covered with a concrete revetment. However, the debris flow which flooded in the upstream attacked this village directly, giving no time of evacuation as one villager accounted “We saw water coming, and the debris immediately hit us”. In Maipon, a mudflow run down the area where “there was no river around here before” (villager) and caused serious damage to the village.

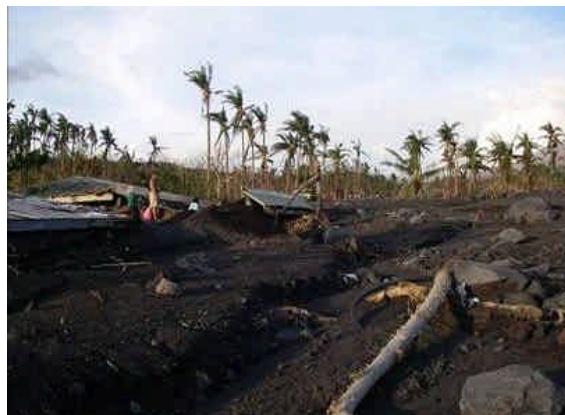
Photo.4 Damage at Maipon(1)

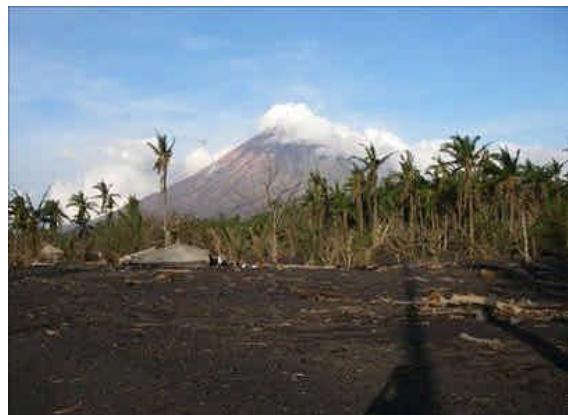
Photo.5 Damage at Maipon(2)

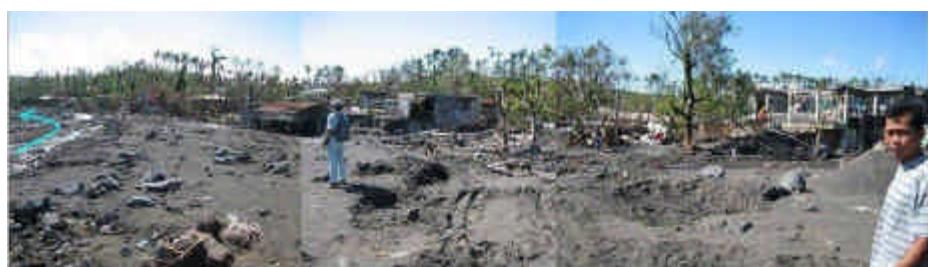
Photo.6 Damage at Daraga Town(1)

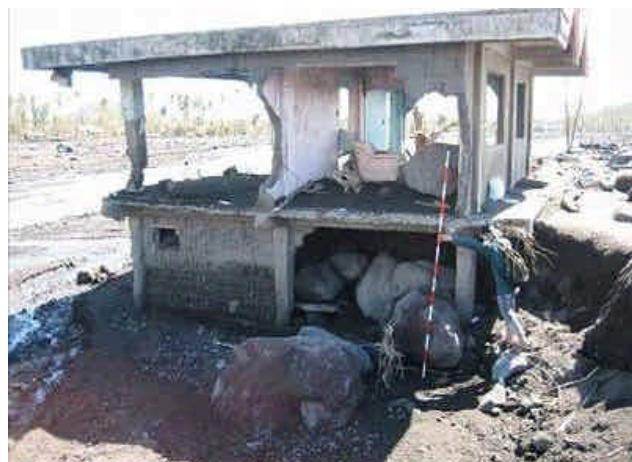
Photo.7 Damage at Daraga Town(2)

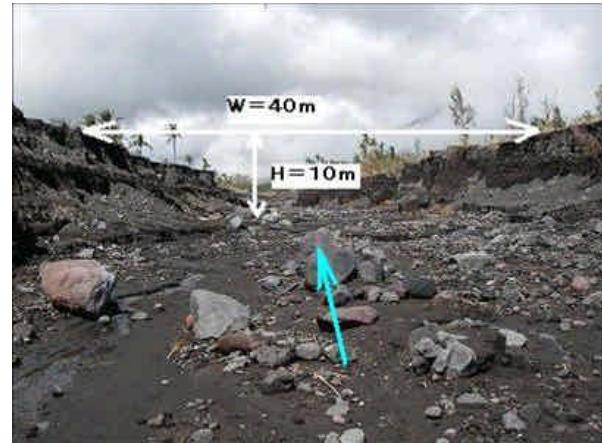
During the helicopter survey, no gullies or large-scale collapses that might provided debris for the current mudflow were found around the top section of the volcano. However, when we surveyed the southern and southwestern foothills about 8 km from the crater in a concentric manner, several large-scale gullies were found. The depth of the largest gully was about 10 m and the width was as large as 50 ~ 200m (Photo 8). It was found that some of those gullies were developed at locations where a gully had never existed before.

Mayon Volcano is made of very fragile geology, and it was presumed that a large amount of rainfall was concentrated into the gullies and it eroded the fragile ground, causing damage to the downstream areas. It was also found that development of gullies at this site was very drastic – they were caused only by half-day rainfall.

Photo.8 Gully caused by the mudslide
