St. Bernard Landslide, Southern Leyte, Field Report

Jesse C. Felizardo, Engineer, FCSEC, DPWH, Philippines
Yoshio Tokunaga, JICA Chief Adviser
Watatu Sakurai, JICA Sabo Expert

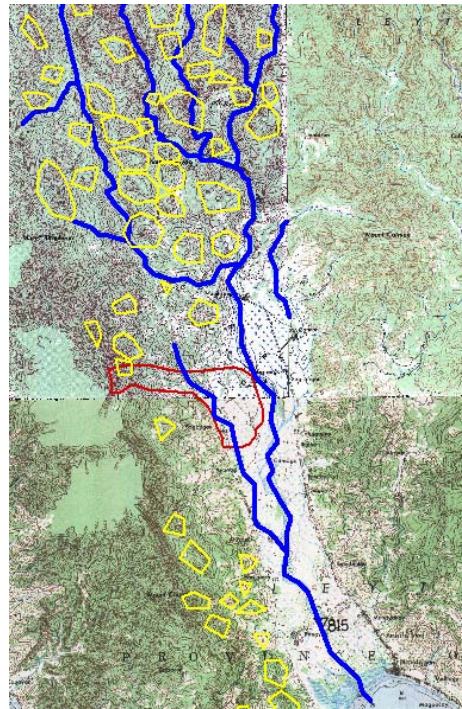
Figure 4, Topographical Map Overlaid with River Systems and Kerncol and Kernbut Around the Area

The major fault lines traverse the municipalities of Sogod, Libagon, St. Bernard and San Juan to Panaon Island. Fault lines run along the middle most stretch of the island of Leyte passing Guinsaguon at the lower tip. Please refer to Figure 4, the topographical map shows the river runs along the fault lines from north to south and the typical terrain has many kerncol and kernbut, enclosed with yellow polygons, which suggests that the area has been affected by existing active fault

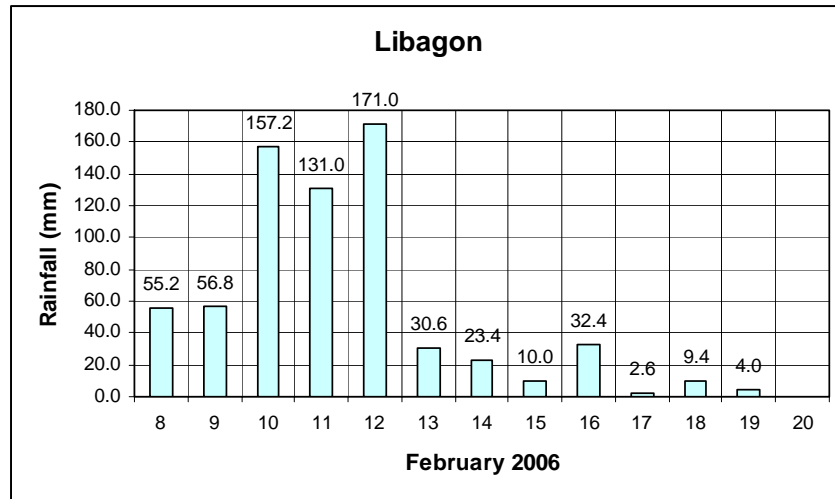
Figure 6, Rainfall Record at Libagon near the Guinsaugon

Prior to the landslide there was antecedent continuous rainfall for two weeks in St. Bernard, Southern Leyte. Libagon raingauge, located approximately 6.8 km southwest of the landslide area (straight distance), registered 787 mm from February 1st to 20th. It peaked from 10th to 12th at 459.2 mm, on the 16th only 32.4 mm and on the 17th only 2 mm and became lighter thereafter up to the 20th. Total rainfall up to the 20th was 271 % higher than the normal compared to the mean monthly rainfall for Maasin, which is 290 mm. From 10th to 12th, there were landslides in Sogod Southern Leyte due to heavy rainfall. After five days. Guinsaugon landslide occurred.

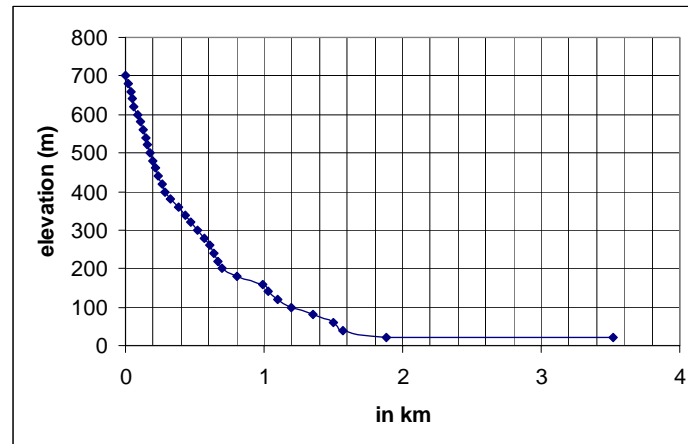
Figure 7 Slope Before the Landslide

The pre-landslide crown elevation was 700 m based on the topographic map with a maximum slope of 45°, mostly vegetated. It consists of sedimentary rocks such as upper Miocene, Pliocene as depicted in the geological map of Mines and Geoscience Bureau. Big boulders with tuff breccia can be found in the depositional area. Collapsed soil has high fluidity which flowed down up to 3 km, horizontal distance, see Figures 7 and 10.

Observation of the geological condition of the slid slope was difficult and dangerous at a very close range. From the front vantage using binocular at the rim of the depositional area, the inclined planar surface on the left is considered impermeable due to the surface runoff after the rainfall and the subsequent collapsed and the sliding of upper layer on the surface. On the right, the steep vertical unstable bed rock exhibits many cracks. Soil mass and splintered rocks spread over the slip surface and its vicinity. Rainfall, even of short duration, can generate debris flow as the boulders, rock fragments, and soil flow along with the runoff on the impermeable surface of the landslide valley. Observed for an hour was short heavy rainfall approximately 10 to 20 mm/hr caused the debris flow,

Before the heavy downpour on February 2006, there were no spring and surface flow on the slide area. Its existence after that rainfall implies that the slope in previous state has fractured cracks as it lies on the fault line, allowing infiltration and accumulation of ground water which triggered the slide.

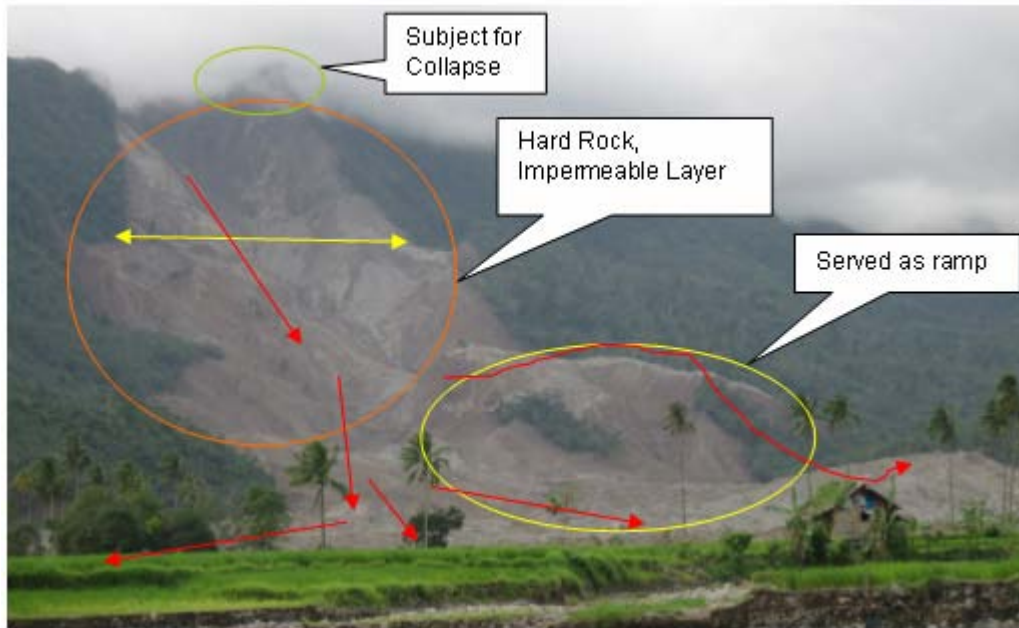
Figure 8 Aerial Perspective of the Landslide Area

The slide area or scarp formed almost a v-cut shape, see Figure 8, approximately 300 to 400 m wide measured in between the undisturbed vegetation and approximately 50 m deep.

Further, the distinction in land cover of the low ridge at the bottom of the mountain, please see Figure 8 in yellow circle, indicates that the collapse moved in high speed, ramped over and landed at a distance.

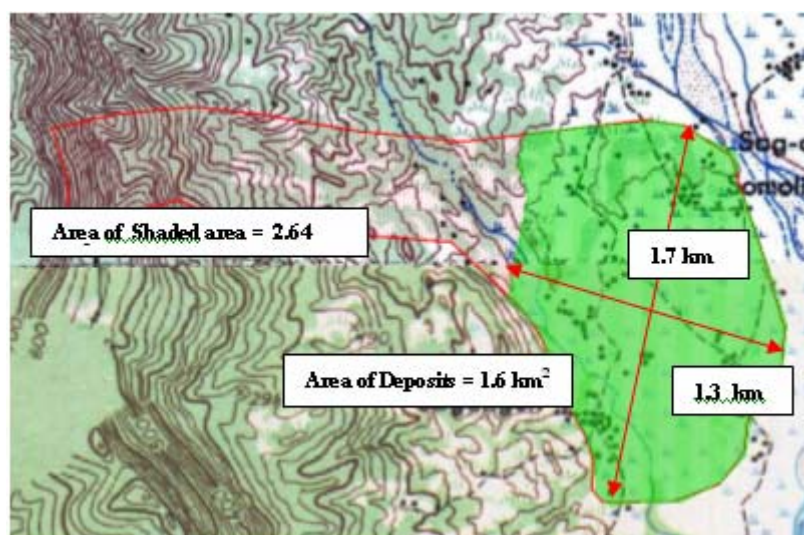
Figure 9 Overview of Sediment Deposition

The extent of slide in Figure 9, measured by handheld GPS and aerial photo from the US Army, is approximately 2.6 km² the area enclosed with red line. The depositional area, the shaded green area, is 1.6 km² reckoned from the foot of the mountain. By observation, the depth of deposition at the rim is up to 5 m, estimated from the exposed buried coconut trees and ± 10 m near the foot. If the average deposition is around 5 m, its volume is around 8 million m³ or if the average depth is as shallow as 3m, its volume is approximately 4.8 million m³, or roughly 5 million m³.

The typical condition of the deposits was that the collapsed soil flowed down for more than a kilometer. Beyond 2 km and farther from the foot of the mountain, the slope is

almost flat exhibiting high water content and high fluidity, which makes it difficult to proceed from the rim to the mid-depositional area.

Deposits are composed of fine sediment, big boulders containing gravel and tuff breccia. Near the river, materials are fractured rocks which differ from other locations.
