Landslide Disaster Caused by Inland Earthquake

1. Overview of North Pakistan Earthquake

3. Investigation of Landslide Disaster Caused by North Pakistan Earthquake

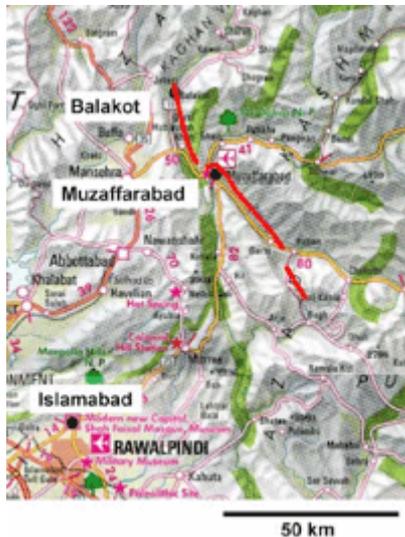
Fig.-1 Outline locations of damaged areas **Fig.-2 Investigation team travel route**

We had an opportunity to inspect the landslide disasters and the damaged situation at the local sites with staff members of Geological Survey of Pakistan on January 20 and 21, 2006. Fig.-6 shows the outline locations of the damaged areas, and Fig.-7 shows the inspection itinerary (Fujiwara, 2006). Although the areas that we visited covered only approx. one third of the entire area that suffers frequent occurrence of landslide disasters, we were able to visit Hathian, which was hit by a massive landslide. Firstly, we went through the settlement called Murree in a pass at approx. 50km north west of Islamabad and at the evaluation of approx. 2000m. Then we went down a valley and went north along the Jhelum River, and reached Muzaffarabad, which was the center of the afflicted areas. It took us approx. 4 hours to travel approx. 135km distance as we passed large landslide areas and some roads with one side closed. Photo-16 shows an example of a road collapse caused by a landslide. The state of Azad-Kashmir, which was the investigation site, was under territorial dispute with India. As we approached Muzaffarabad, tents for the victims were increased. In the city, collapsed middle-rise buildings and low-rise houses were found here and there. The mountain slope at the north of the city was totally

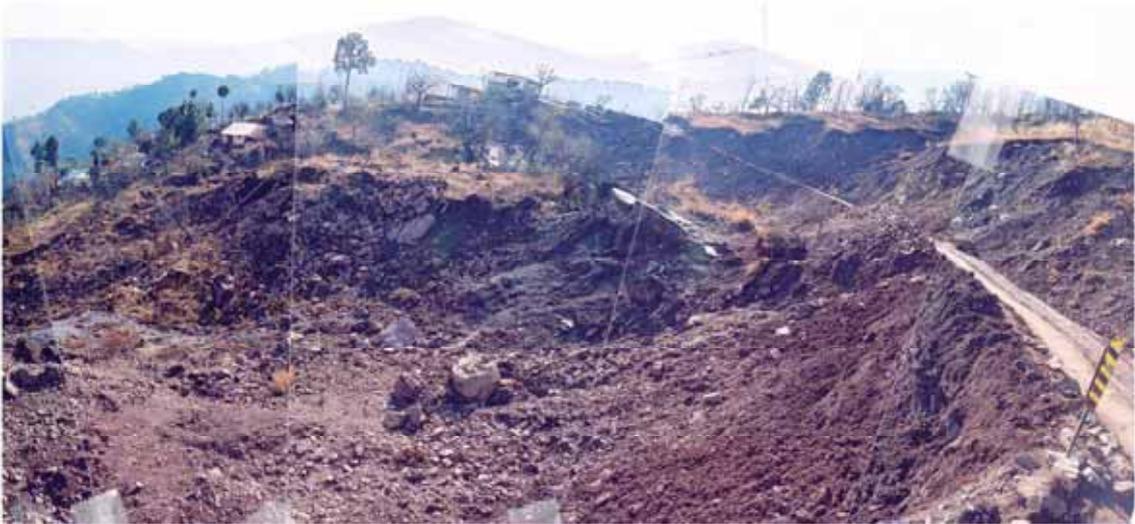
Photo-1 Collapsed roads due to landslide

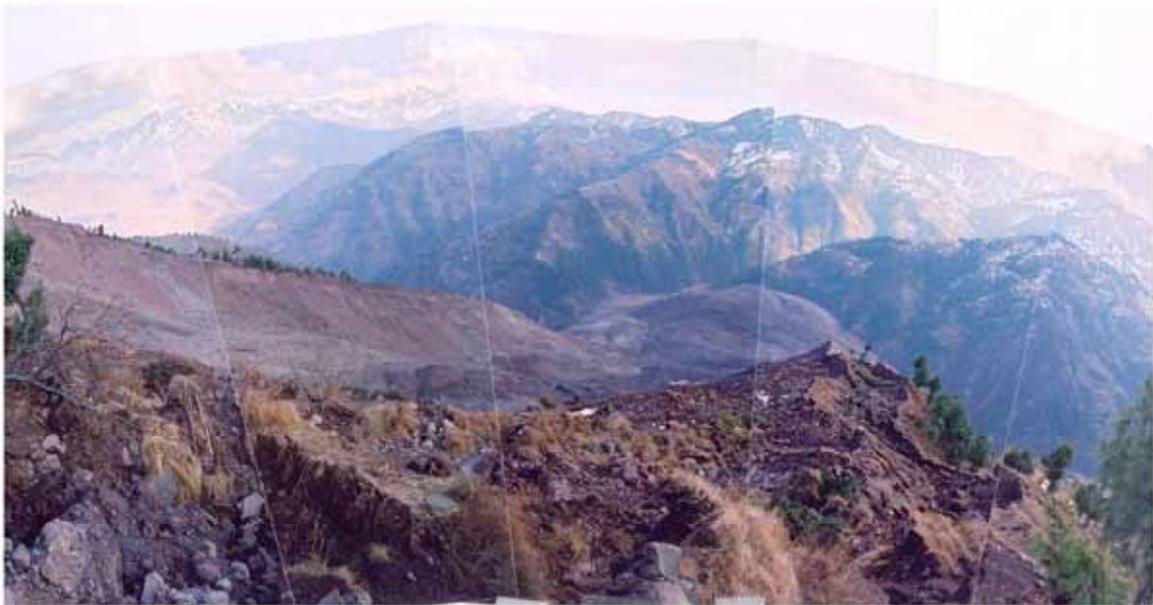
Photo-2 Hathian landslide (Seeing the landslide area from the side cliff at the upper side)

In the Hathian landslide area, the mountainside collapsed from north to south and created a debris avalanche deposit, of which width is 500m, slope length is 2km, and depth at the deepest part is more than 100m(Photo-17). The debris of more than 10^7 m^3 blocked the confluence of the two branch valleys, forming two landslide dams. It is presumed that this mountainside collapse was not first time occurrence, but an existing landslide was expanded to the upper side, resulting in the collapse (Schneider, 2006). The debris from the landslide is composed of red sandstones, siltstones, and mudstones of the Murree layer of early Miocene. The cross section of the debris is a wedge shape of a right triangle of which the base is the ground surface, long oblique line is the slope, and the short oblique line is the east side of the collapsed cliff. The slope is parallel to the bedding plane of the bed rock. Along with the collapsed cliff side, many cracks and multilevel terrain were formed, and remaining large debris was found right under the top of the mountain.
