Report on Investigation of Sediment Disasters in the Republic of Korea

Junichi Kurihara (Senior Researcher, Erosion and Sediment Control Research Group, Public Works Research Institute)

Toshihiro Hashinoki (Acting Chief, Sabo Technical Center)

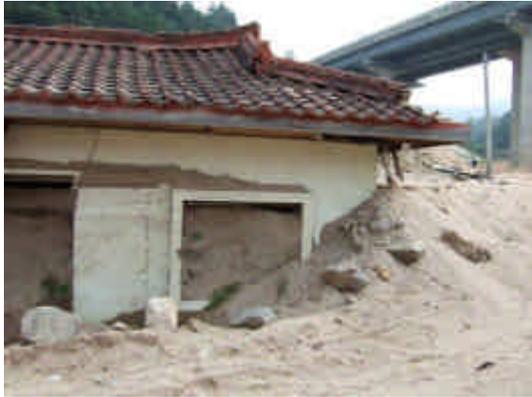
Photo-1 Damage to Soksa 1-ri

Photo-1 shows a large amount of sediment (sand) is heaped and buries houses. Photo-2 is a distant view of the same area. From these photos, you can learn that the amount of sediment was overwhelming.

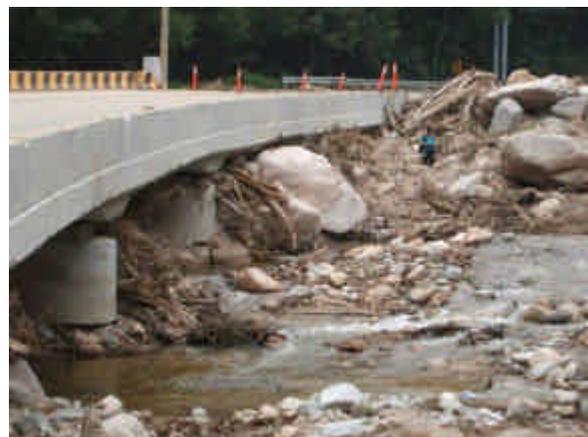
Photo-3 shows the closure of a bridge in Buk-Hangye. It was completely closed, and the bridge beams were displaced by approx. 30cm at the joint part. Photo-4 and 5 are an air view of a flood caused by meandering and an enlarged view of the disaster affected area. It reminded us of disasters related to river Sabo in Japan several decades ago.

Photo-3 Bridge closed with rocks and driftwoods; Bridge beams displaced by 30cm (Buk-Hangye)

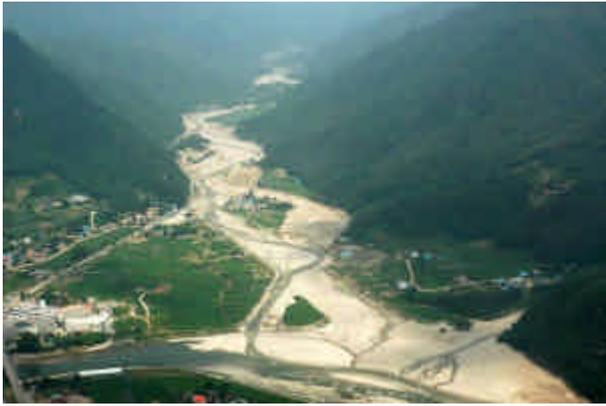
Photo-4 Meandering and flood at Buk-Hangye

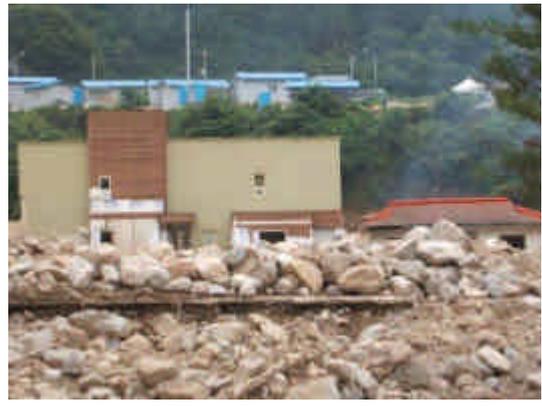
Photo-5 Damage to houses at Buk-Hangye
