La Conchita Landslide

President of GT International Consultants
Naohiko Noguchi

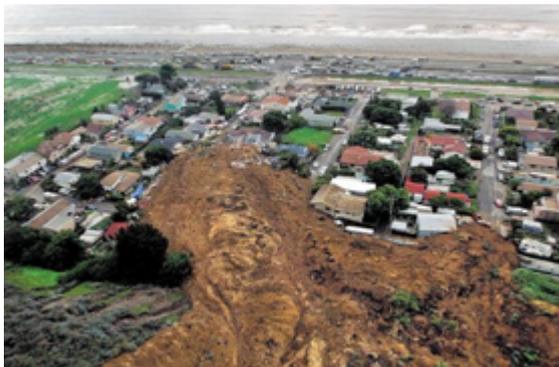
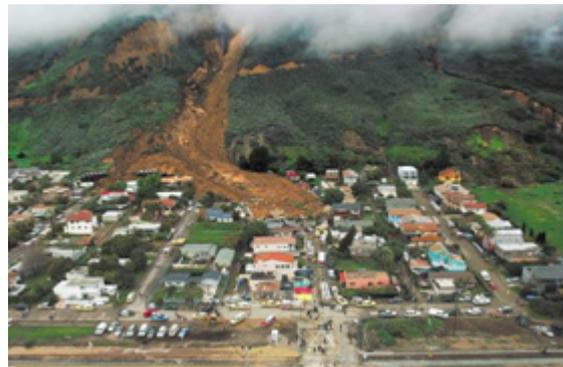
At 2:05 pm on Monday January 10, 2005, a steep slope behind the housing development at La Conchita, failed cascading approximately 400,000 tones of debris, and killed 10 people, buried 13 homes and damaged 18.
