Unzen-Fugendake Eruption Executive Summary

1990—1995

November 2007

In the current outline report, the above-mentioned Unzen-Fugendake volcanic disaster is summarized.

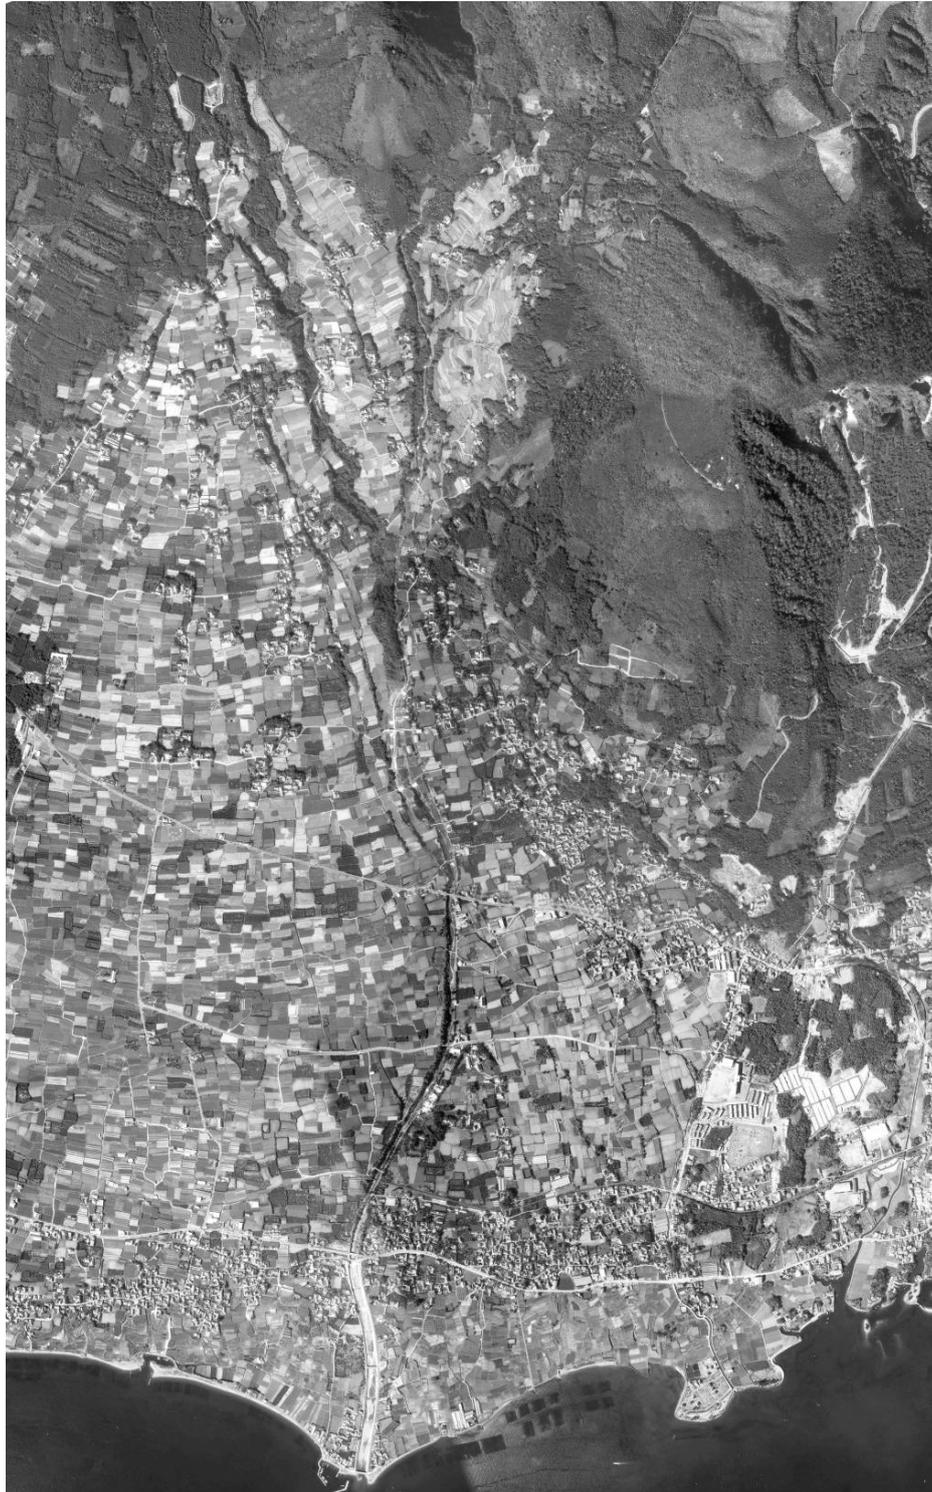
1. Status of Misunashi River area before the disaster (Spring 1981) (Photo: Kokusai Kogyo Holdings Co.)

Note: Mt. Fugendake is upper outside section. Mizunashi River indicates a serpentine line in the center. The horizontal line in the lower section is National Highway #251. The line above the National Highway #251 is agricultural road. The line slightly tilted to the right direction above the agricultural road is the National Highway #57. The pyroclastic flow occurred on July 19, 18: 21 reached 100m downstream of the National Highway #57.

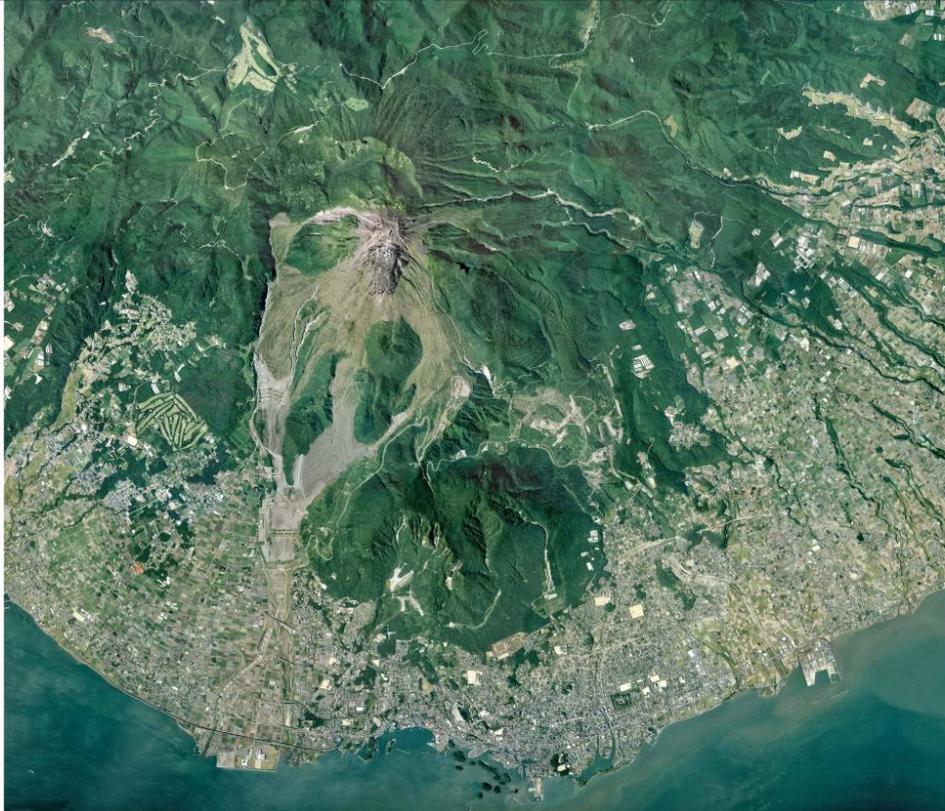
2. Complete view of Unzen-Fugen and the disaster-affected area (September 27, 2003)

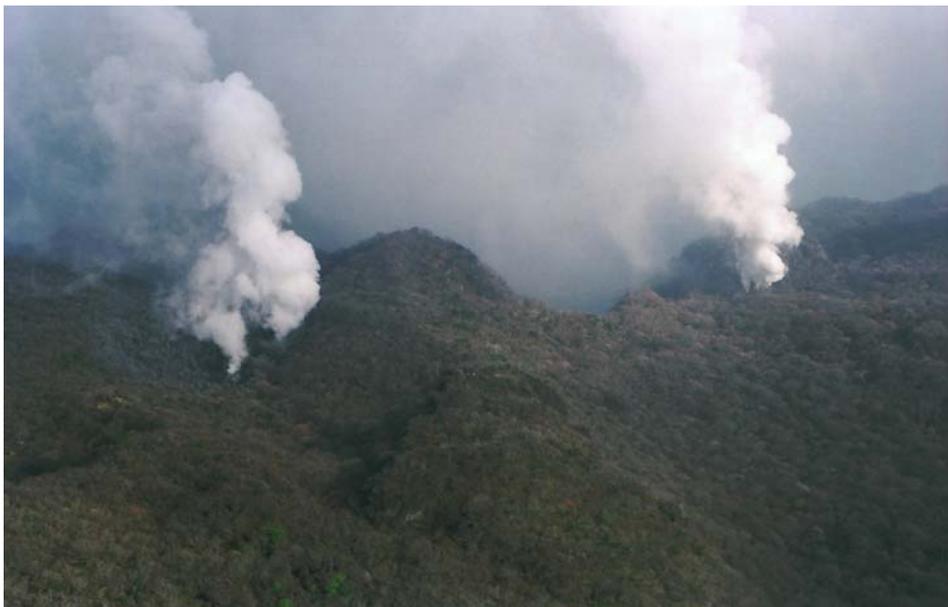
3. Eruption after the interval of 198 years (November 17, 1990) (Photo: Kazuya Ota)

Note: The volcanic smoke on the left indicates the Jigokuato crater. The elevated section on the right front is Byobuiwa. The volcanic smoke in the right is from Kujukushima crater.

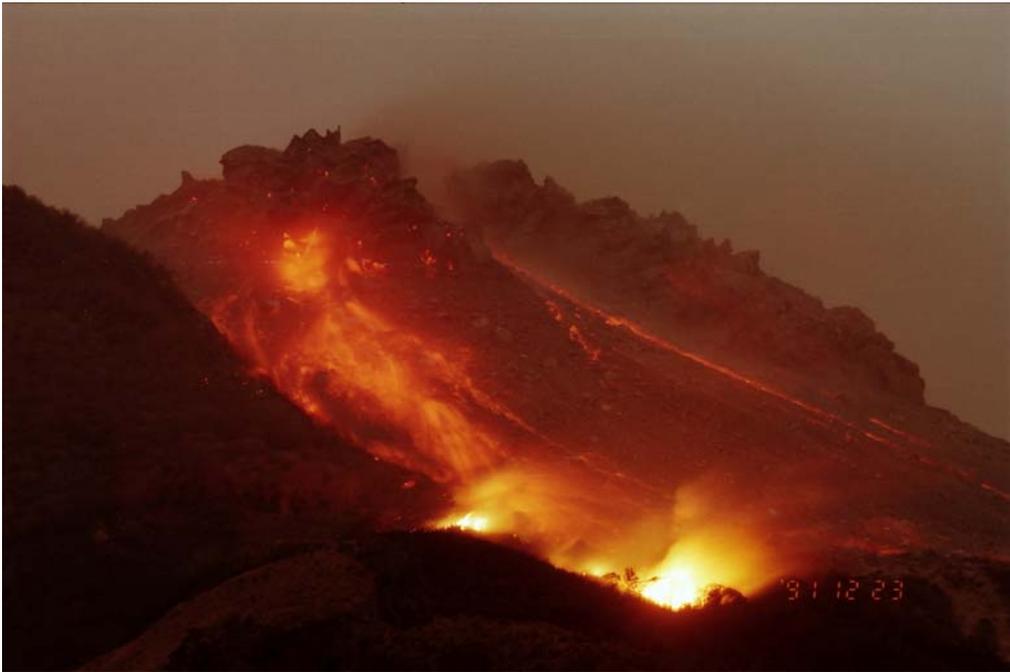
4. Fire in Akamatsu Valley caused by pyroclastic flow (December 23, 1991) (Photo: Shinichi Sugimoto)

With the collapse of lava block from the lava dome on May 24, a pyroclastic flow occurred at the east hillside of Mt. Fugendake. Thereafter, frequent pyroclastic flows were observed with the growth of the lava dome (**Front picture 4**). While total incidence of the pyroclastic flow reached about 6,000 times, low distance exceeded 4km in some of them. The lava extrusion reached 0.3~0.4 millionm³ / day during the peak period, resulting in formation of multiple lava lobes (**Figure 1**). While lava extrusion almost stopped temporarily in the end of 1992 (**Front picture 5**), it resumed in February 1993. Since then, formation of lobes and pyroclastic lava cones occurred with fluctuating volume of extrusion, following which a single gigantic lava dome was formed finally. When the eruption terminated in February 1995, total lava extrusion amounted to 200 million m³, the half of which remained as lava dome and the other half became pyroclastic flow sediments as a result of collapse during the process of growth (**Figure 2**) (**Front picture 6**).

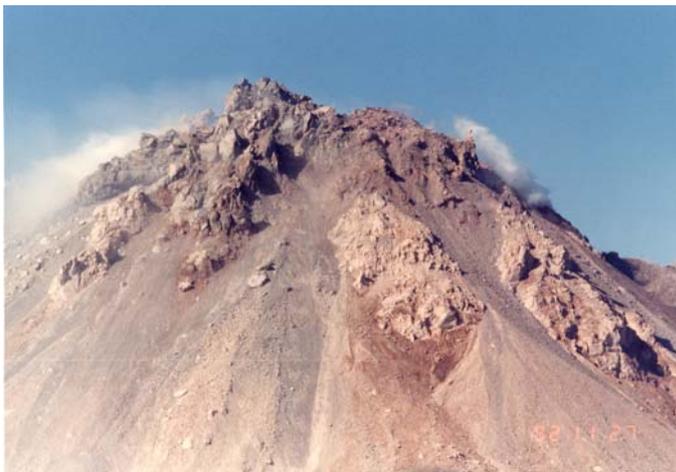
5. Growing lava dome (November 27, 1992)

Note: Lobe No. 8, Lobe No. 6, Lobe No. 4 from left. Pyroclastic lava cones is seen in the center right.

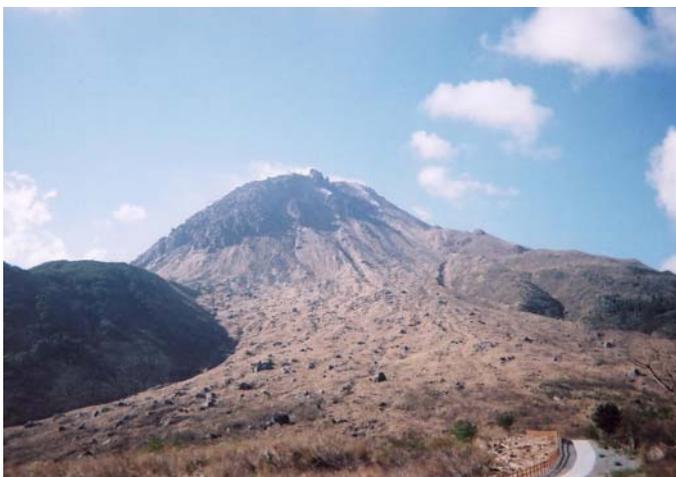
6. Lava dome of Unzen-Fugendake and pyroclastic sediments filling the valley (November 9, 2001)

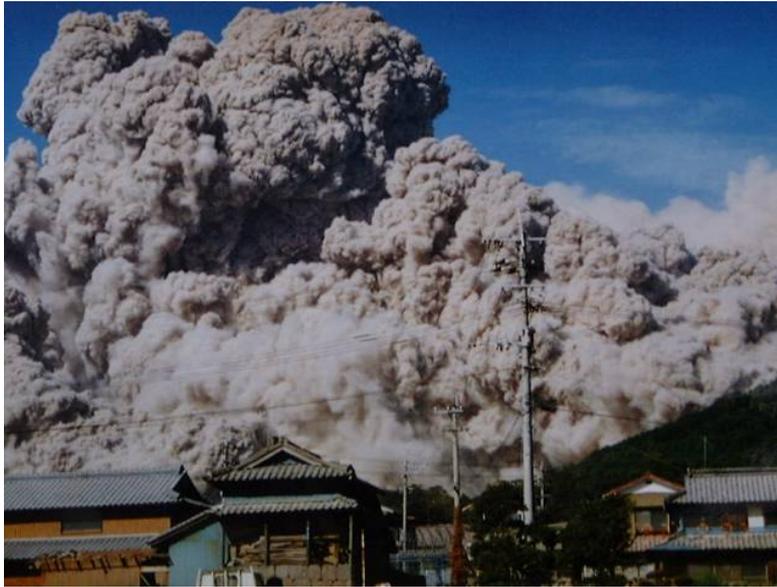
7. Pyroclastic flow approaching houses (September 27, 1992)
(Photo: Shinichi Sugimoto)

In 1992, most of the pyroclastic flows flowed towards southeast direction, gradually filling Akamatsu Valley (**Front picture 7**). In 1993, pyroclastic flow was frequently bound for Northeast hillside heading for Oshiga Valley or Nakao River. On June 23, 1993, during the pyroclastic flow in Nakao River direction, many houses in Senbongi district of Shimabara City were burned and a male citizen who accessed the hazard area to check his house was killed due to systemic burn. Further, repeated debris flows from April to July gave serious damages on many houses and disconnection of national highways and Shimabara Railroad at multiple locations caused temporary isolation of urban districts in Shimabara City.

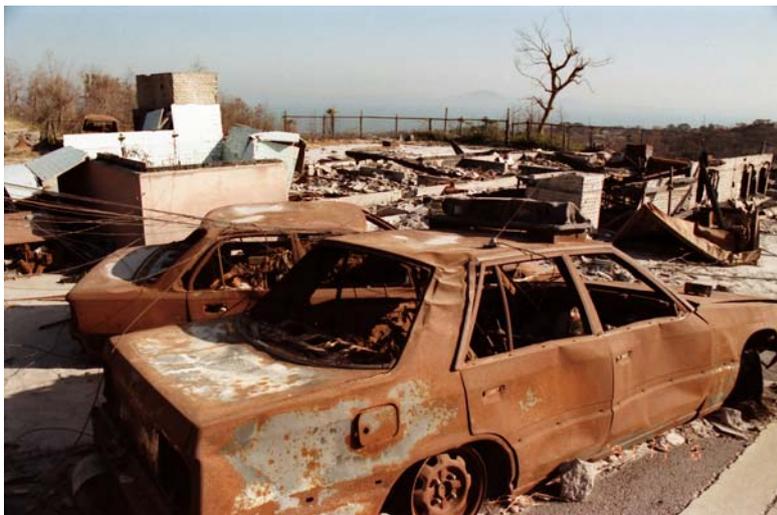
8. Ruin of Kita-Kamikoba Farming Training Center damaged by pyroclastic flow on June 3, 1991, when many people lost their life. (November 6, 1991)
(Photo: Shinichi Sugimoto)

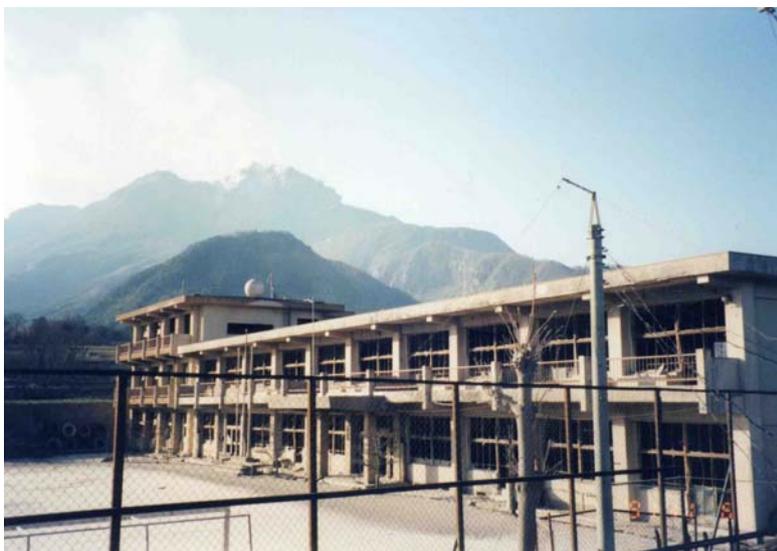
9. Ono-Koba Elementary School in Fukae Town was burned down by pyroclastic flow in September 15, 1991 (November, 1991)
(Photo: Shinichi Sugimoto)

Note: The ruin of the school has been preserved as a historic object of pyroclastic disaster.

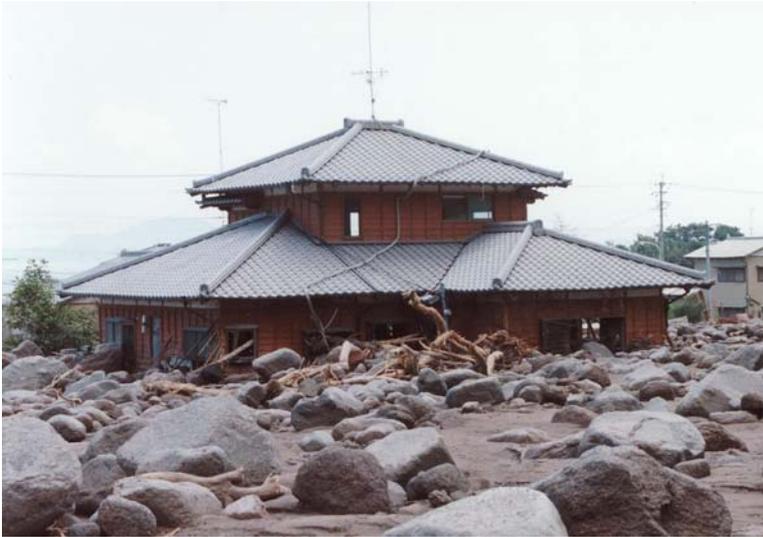
10. A house aggraded by debris flow
(April 30, 1993)
(Photo: Shinichi Sugimoto)

Meanwhile, 2,511 houses were destroyed, most of which were attributable to the debris flow and the remaining parts were due to fire caused by the pyroclastic flow (**Front picture 10**). Because education facilities were included in the building damage, there was a severe impact on the school education activities.

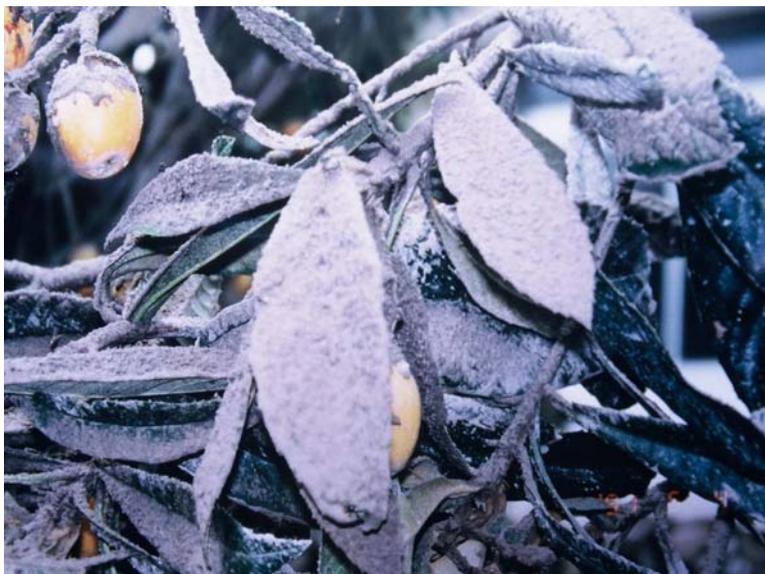
20. Biwa fruits covered by volcanic ash (May 1992)
(Photo: Tokinao Iwanaga)

Besides, the details of the total accumulated agricultural and forestry damages during 1991-1995 were as follows: damages on livestock industry were 21,591,399,000 Yen, damages on farmlands were 18,143,000,000 Yen and damages on forestry industry were 26,374,998,000 Yen, which added up to 66,109,397,000 Yen in total. The repeated debris flows and ash falls gave damage on the marine product industries too, centered on coastal fishery. The fishery production from Ariake Sea reduced by 58% in quantity and by 44% in value versus 1995 (**Front picture 20**).

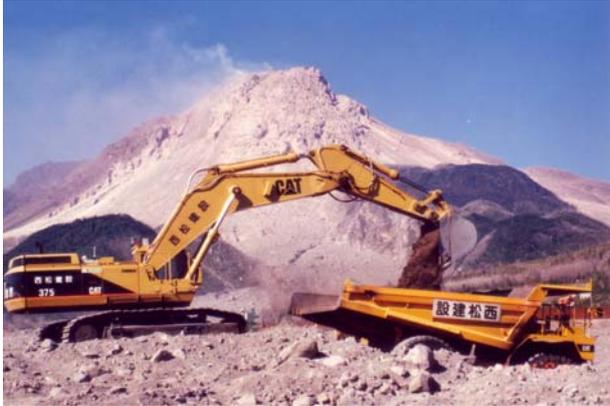
23. Sediment removal inside hazard area using unmanned technique (April 11, 1994)
(Photo: Munehiro Matsui)

After the pilot construction, full scale sediment removal construction was carried out from 1994 to 1995 on the unmanned bases (**Front picture 23, 24**). In the process of this

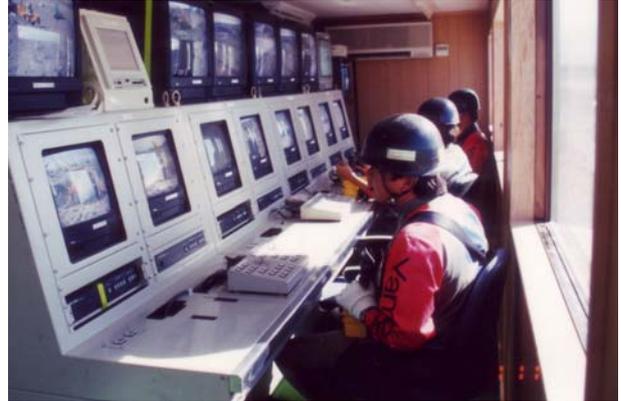
24. Remote controlling for unmanned construction work (April 11, 1994)
(Photo: Munehiro Matsui)

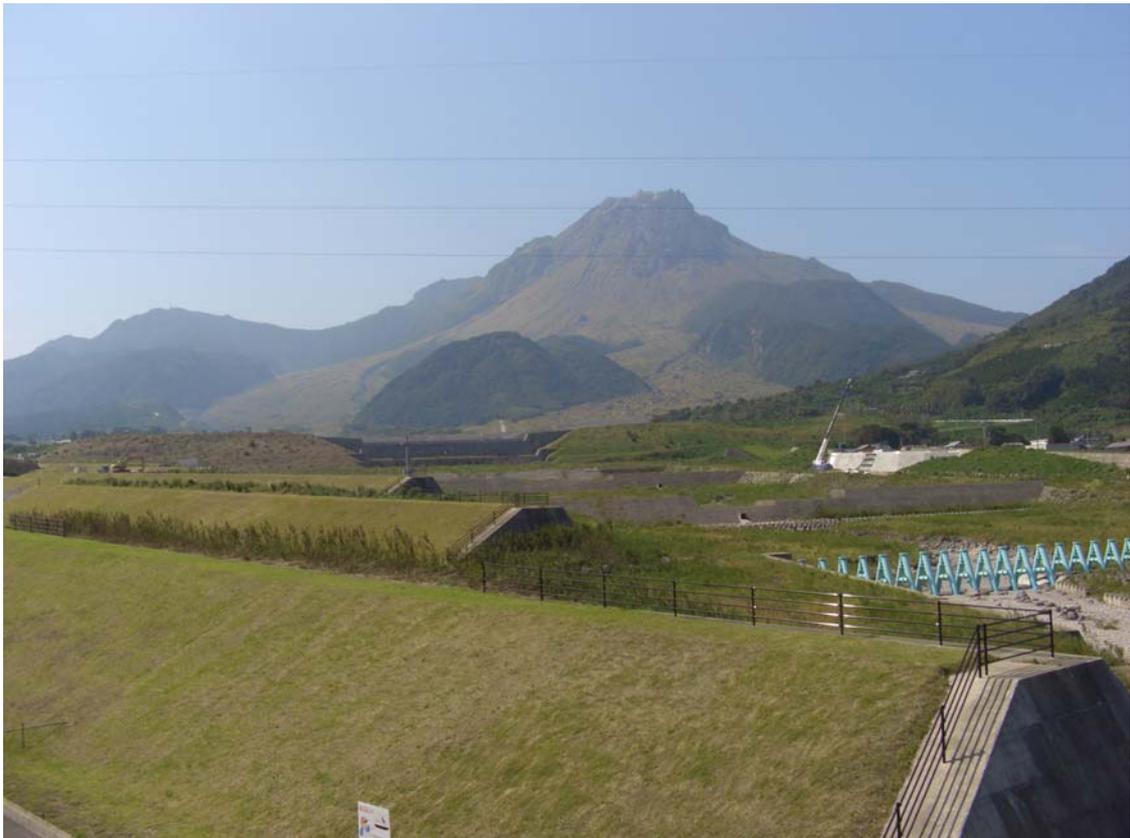
25. Training dike in Mizunashi River, sabo dam and Mt. Fugen (August 23, 2006) (Photo: Munehiro Matsui)

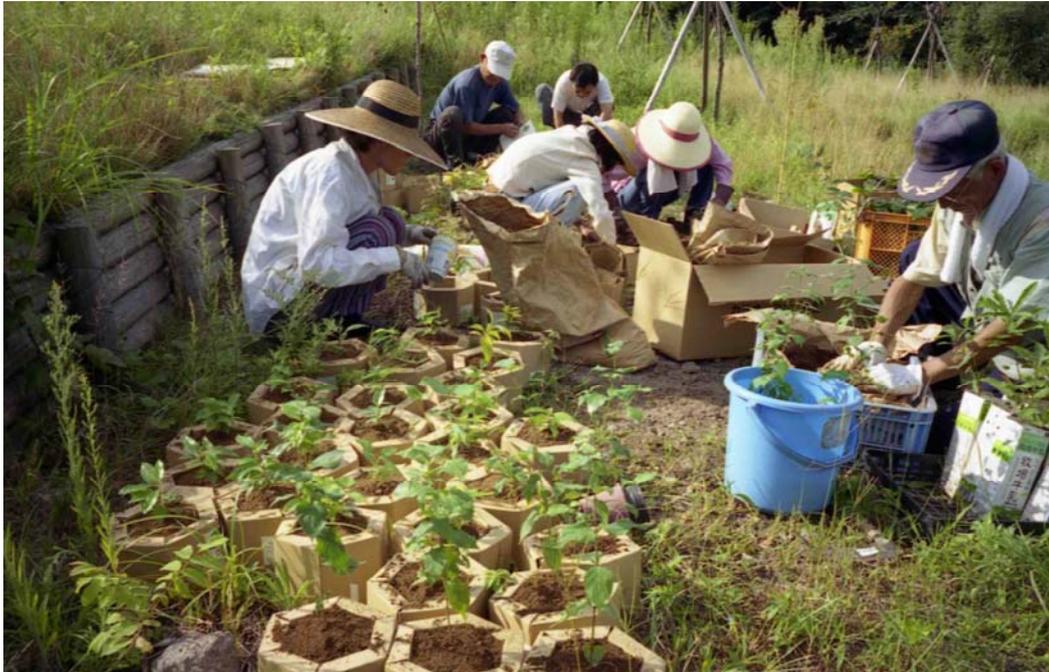
26. Reforestation approach using indigenous plants (May 2001) (Photo: Shinichi Sugimoto)
