Warning System employing Photo Chronograph Technology
installed at the Construction Site of the 4th Check Dam in Shiratani Valley

Tochio Field Office
Zintsu River Erosion Control Project

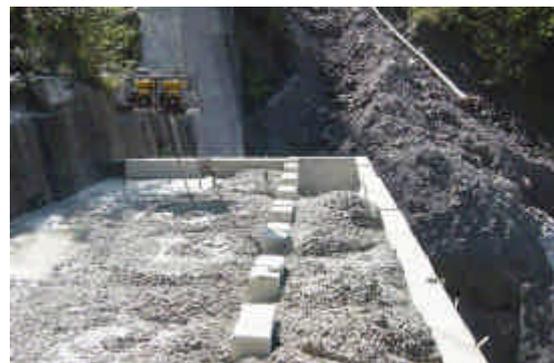
Photo1: Tamping by unmanned vibrator

The dam site is so dangerous for a man to work that a two third of the site became off limits to workforce. Accordingly the area was designated as the unattended construction area in which. (Photo1)

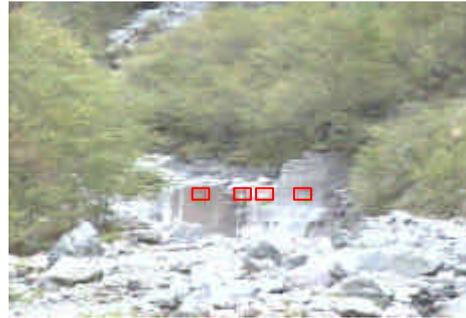
In this case, the sensor system assesses gaps in contrasting density among five images taken successively once every 0.5 second. The target stretch of the valley in which a debris flow is initiated is located 300 meters upstream from the monitoring camera. Images of the target stretch are taken by the camera set up 100 meters upstream from the dam site. (Photo2)

Photo2: The detection area (The site of)

The sensor system employing photo chronograph enable changes in two consecutive images to be automatically identified. The principle of the sensor system is to detect differences between two consecutive images by identifying gaps in contrasting density. The gaps in contrasting density mean the filmed targets are moving.

In another word, as soon as the gaps in contrasting density between two consecutive images exceed the threshold value, the warning system is mobilized.
