## **Central Java Earthquake Assessment of Rehabilitation and Reconstruction Needs**

### **Report of Survey on the Prevention of Secondary Disasters (Sediment-related Disaster Planning)**

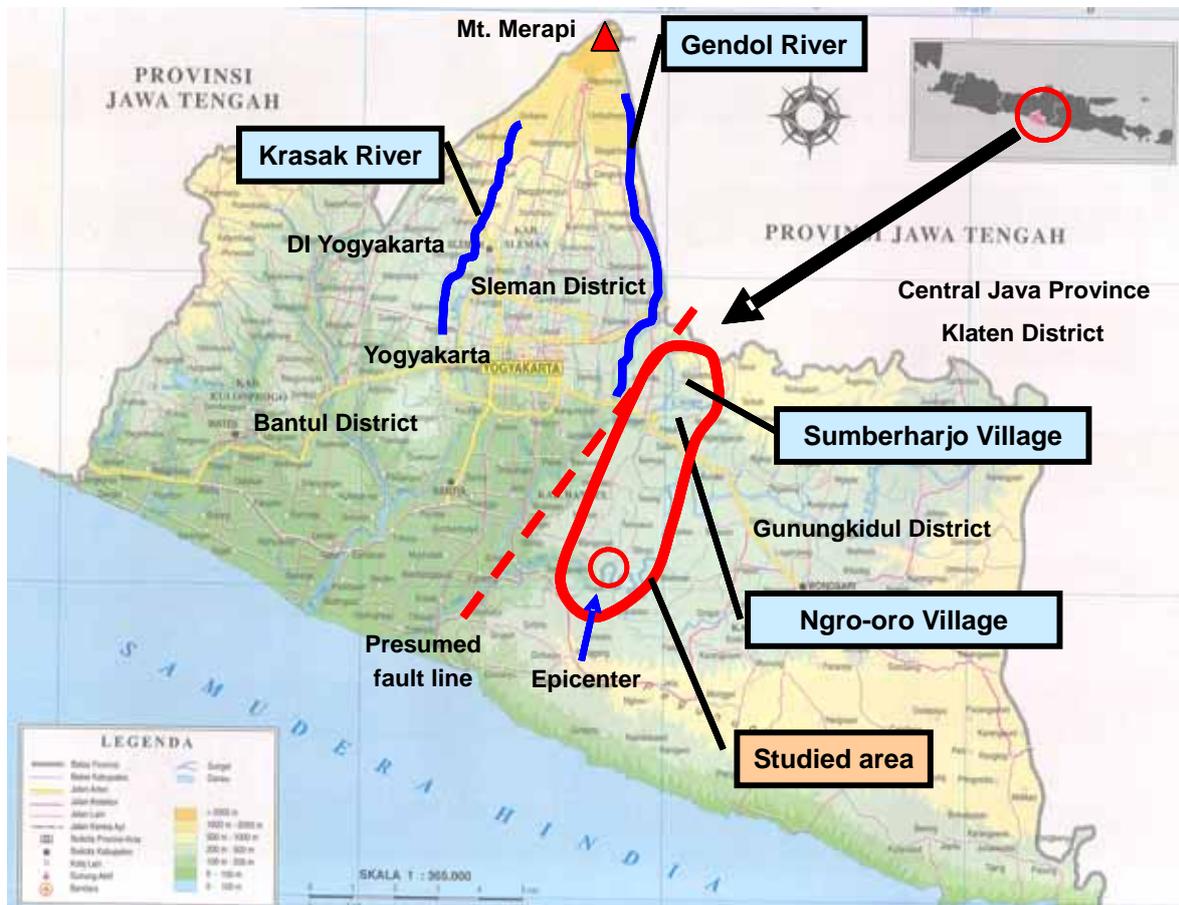
**Figure 5.1: Studied area**

The study of the slope failures caused by the earthquake was conducted in an area extending from around the epicenter in the Bantul District to the borders between the Bantul, Sleman and

Gunungkidul Districts in the mountains east of the Bantul District, which were presumed to have suffered the slope failures because of the closeness to the epicenter (Figure 5.1).

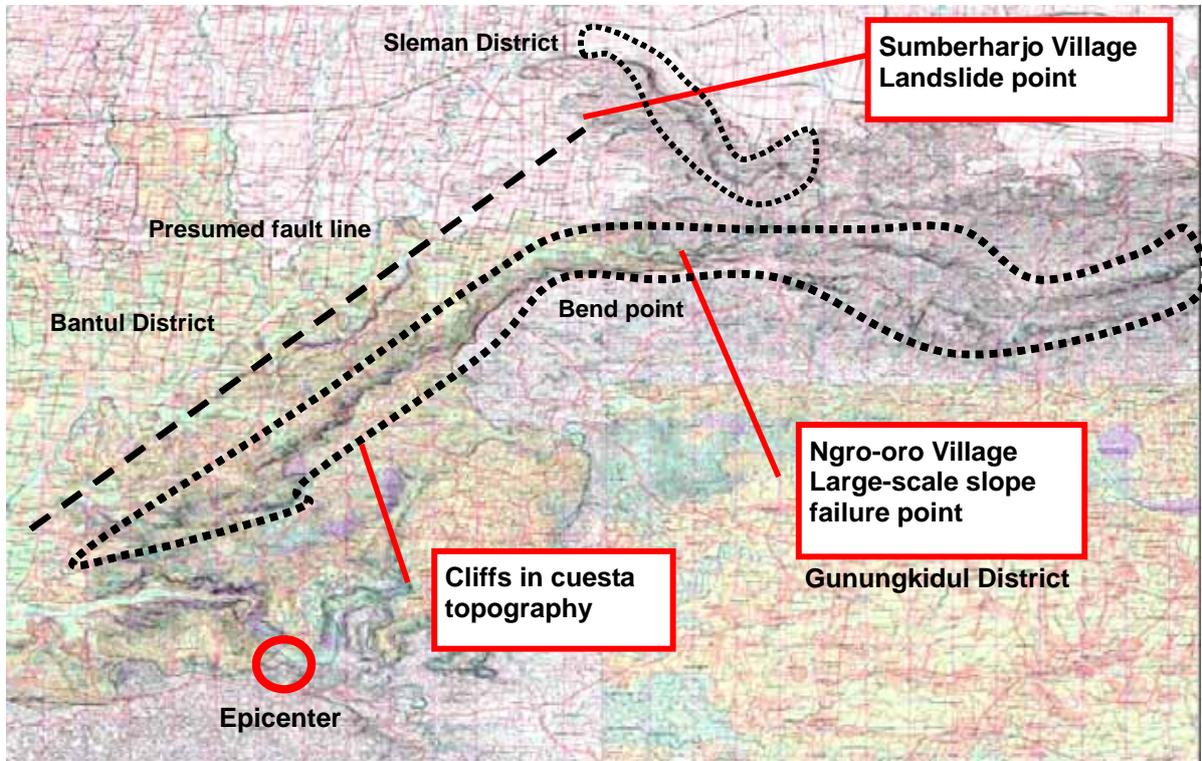
**Figure 5.2: Mountain topography overview (fault line roughly indicated based on Kompas June 3, 2006)**

This mountain terrain extends northeast about 30 km from the southwestern part of the Bantul District, bends in the shape of an L along the borders between the Bantul, Sleman and Gunungkidul Districts and goes on to run eastward (Figure 5.2).

The topography can be described as hilly mountains of about 500 m above sea level. While the slopes facing northwest or north make cliffs (on the Bantul and Sleman side) that fall into a plain stretching from Yogyakarta, the slopes facing southeast to south that are on the other side (on the Gunungkidul side) are gentle inclines, which make a cuesta topography (Figure 5.2, Photo 5.1).

Regarding the geological condition, the Bantul and Sleman side has prominent tuffs and tuff breccias and the Gunungkidul side, the opposite slope, is composed mostly of limestone. At the base of the mountain on the Bantul and Sleman side, the earthquake fault presumed to have been active in the earthquake is considered to extend from northeast to southwest.

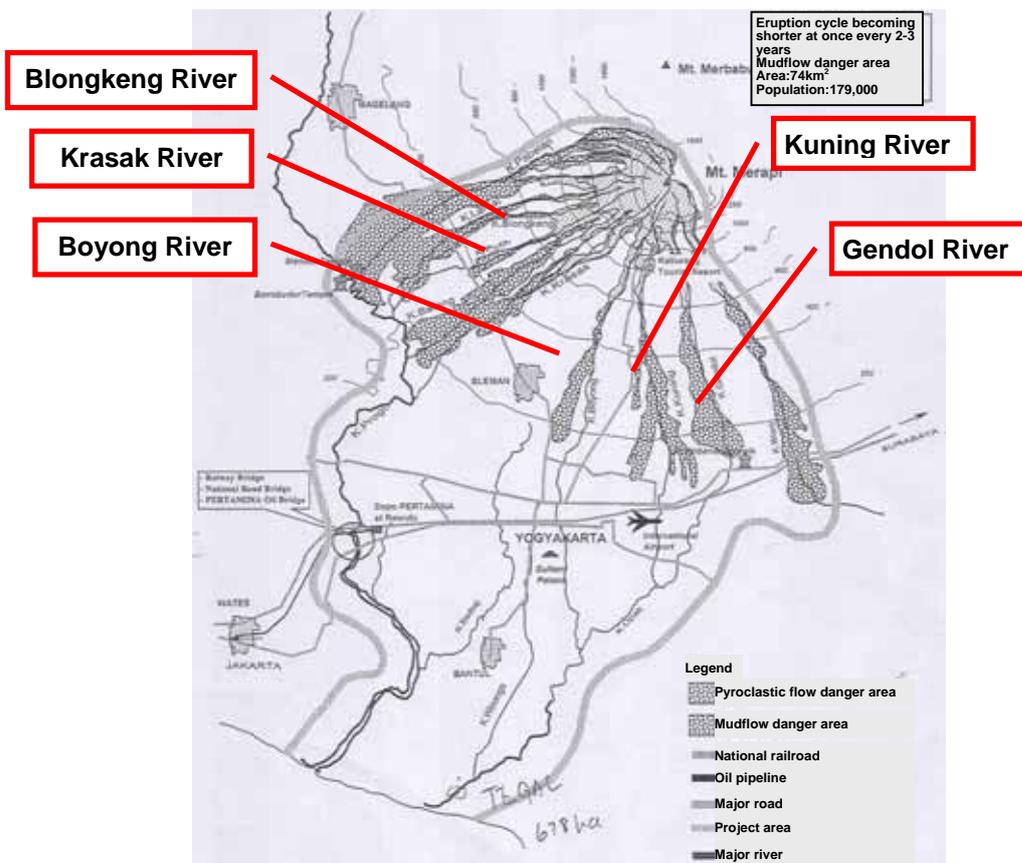
**Figure 5.3: Rivers around Mount Merapi**

As a result of on-site visual observation of the spread of the pyroclastic flows, the flow-down towards Gendol River is prominent (Figure 5.3) and the distance of flows is longer than for any other rivers at about 5 km, or about 1,200 m above sea level. In addition, the accumulation of the pyroclastic flow deposits in three directions has been reported: towards Boyong, Kuning and Blongken Rivers (Photo 5.18). This causes the risk to rapidly grow of the increase of pyroclastic flow deposits due to the flow-down and of massive mudflows caused by possible erosion of the deposits in the rainy season along these rivers.
