St. Bernard Landslide, Southern Leyte, Field Report

Jesse C. Felizardo, Engineer, FCSEC, DPWH, Philippines
Yoshio Tokunaga, JICA Chief Adviser
Watatu Sakurai, JICA Sabo Expert

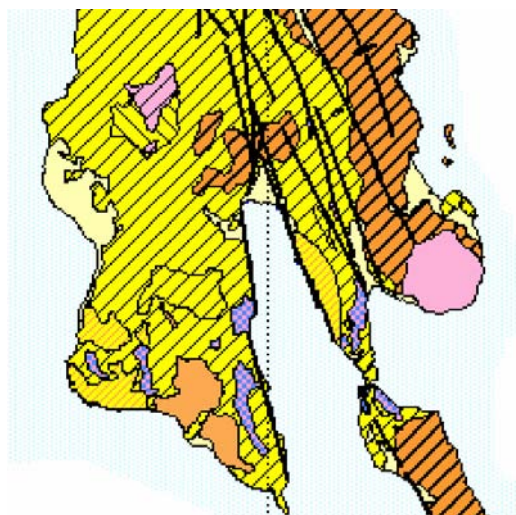
Figure 2 Fault Lines along Leyte

Himbangan river runs from Mt. Abuyog crisscrossing to flat plains of Guinsaugon and Catmon and discharges to Cabalian Bay. Referring to the geological map, Figure 2, The upper portion of St. Bernard belongs chiefly of tuff, tuffies and tuffaceous sedimentary rocks. and the lowlands are quaternary The plain area is recent – described as alluvium, fluvialite, lacustine, paludal, and beach deposits, raised coral reefs, atolls and beachrock.
